Shear Discontinuity along the Sone River Bed at the Bansagar Dam Site, South of Rewa, M.P.

K. M. Bangar*

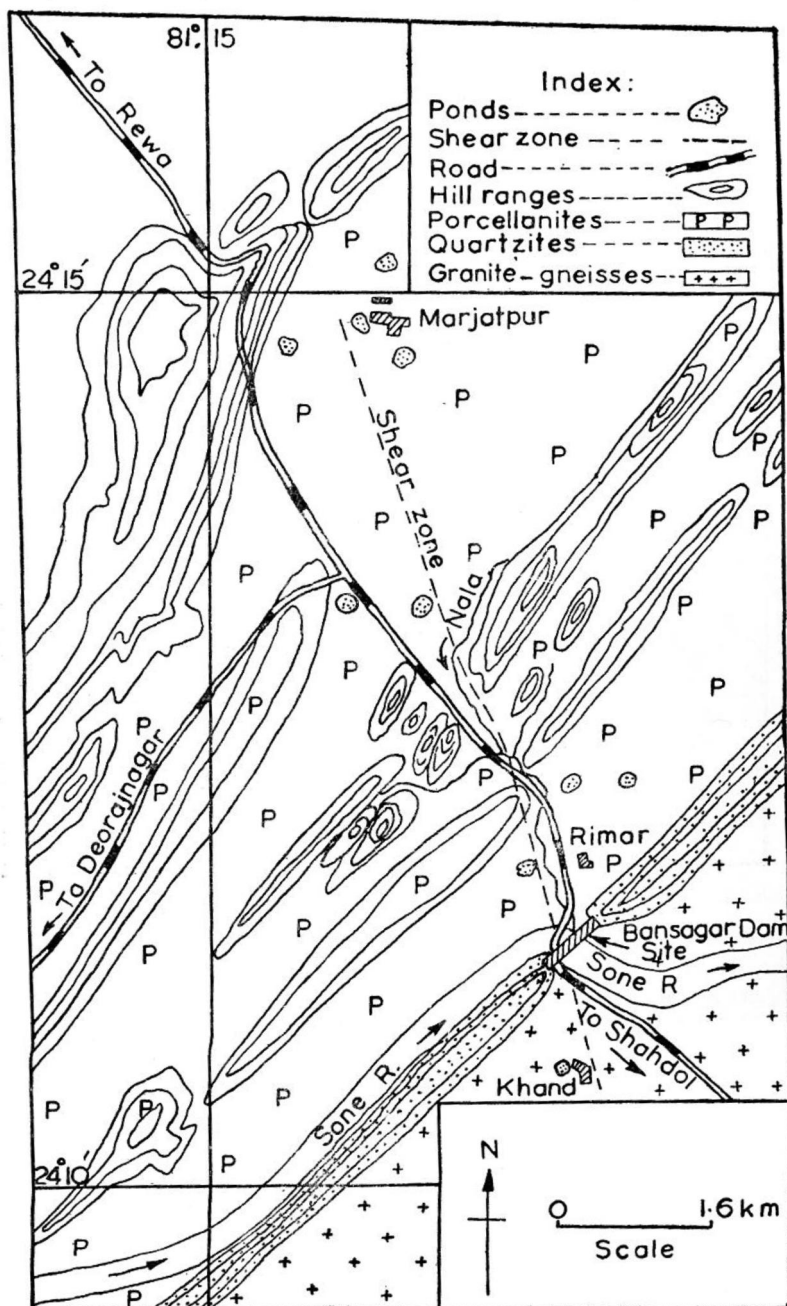
FIGURE 1: Geologic and topographic map showing trend of shear zone.

A linear depression running from the gorge towards N10°W in the direction of the shear zone can be traced right up to Marjatpur village for a distance of about 7.5 km. The valley intersects the porcellanite-ridges across their trend, and contains a nala. The valley may have formed due to the presence of crushed rocks along the shear zone which have yielded easily to erosion. Further, the discontinuous porcellanite-ridges and knobs lying adjacent to the valley, appear as if they were off-setted (Figure 1), suggesting that some movements have occurred along the shear zone.

Eight small ponds have been spotted in the 7.5 km long shear zone trench lying in-between Marjatpur and Rimar villages (Figure 1). They probably contain ground water, which have ascended through the shear

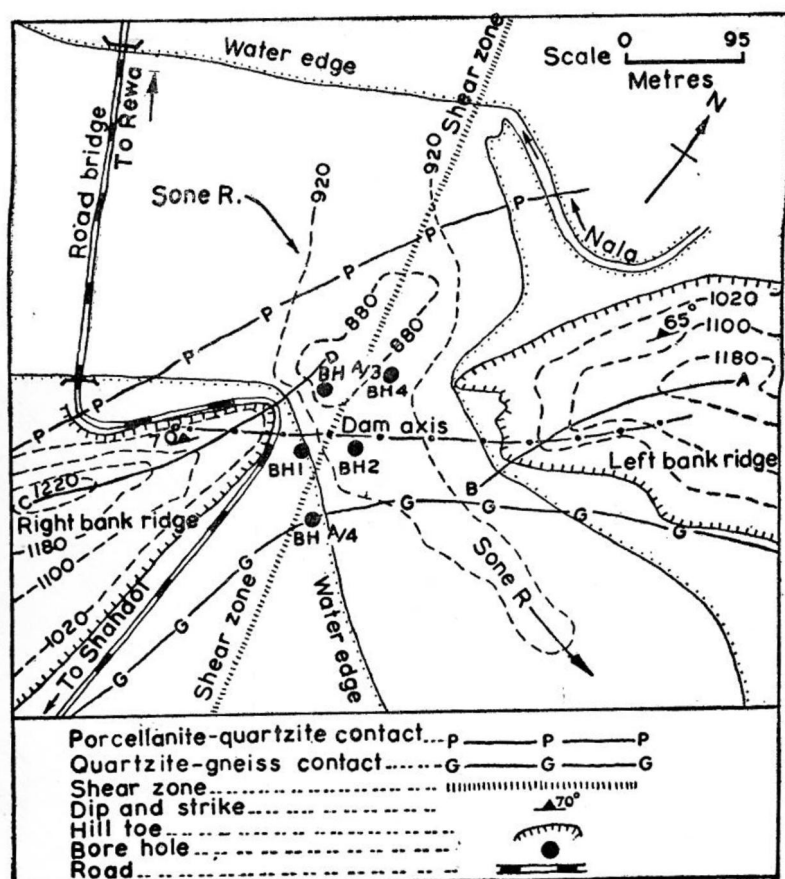
FIGURE 2 : Gorge at Bansagar Dam site showing pool and position of the shear zone (Plan reproduced from Report on Bansagar Project, Vol. II).

Where a river makes a pronounced bend in its course, the thread of maximum current and location of greatest turbulence occur along the concave bank. As a result the concave bank becomes the site of concentrated erosion and the channel is dug obliquely towards it instead of being dug vertically. At the sharp bend in the Sone River, which exists near the gorge at Bansagar Dam site, the deepest spot, having depth of about 24.38 m has been located near the Right Bank Ridge, which is the convex-bank side (Figure 2). This anomaly suggests that the position of the fracture zone may be close to the Right Bank Ridge.

A pool of 24 m depth is present in the Sone River bed, in the Basal quartzites near the gorge. It has been considered as a plane erosional feature. Had this pool been originated due to simple river erosion, then according to law of head word erosion, there would have been intensification of retrogressive erosion, and the river bed would have a tendency to assume a smoother curve approaching a horizontal line in the lower stream. But this is not the case here. The configuration of the pool (Figure 2) shows that there has been very limited down cutting at its outlet by the out flowing water.

As shown in Figure 2, the pool is elongated in the direction $N10^{\circ}W-S10^{\circ}E$. This direction of elongation does not coincide with the direction of river flow. It means that the excavation of the pool in the above said direction is not done exclusively by river erosion but the possibility is that the pool has been opened out in that part of the river channel which coincided with the shear zone. Thus the shape of the pool gives a clue to the direction in which the shear zone may be running.

From the Figure 2, it is clear that the lines AB and CD, drawn by joining the nose of contours of the two ridges lying on either side of the gorge show curvature in opposite directions, thereby indicating some disturbance.

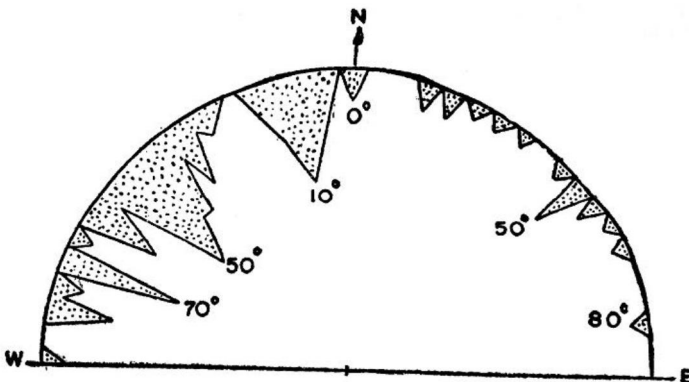
The study of the joints of the rock beds lying in the vicinity of the shear zone has been done and the strike directions of nearly 150 joints have been measured and analysed statistically with the help of "rose diagram" (Figure 3). In the diagram the longest rays are in the directions $N10^{\circ}W$, $N50^{\circ}E$ and $N50^{\circ}W$, which indicate the trends of predominant fissures present in the area. This analysis supports the inference already made, that the shear zone strikes in the direction $N10^{\circ}W$.

FIGURE 3 : Rose diagram indicating positions of predominant fissures in the area near Bansagar Dam site.

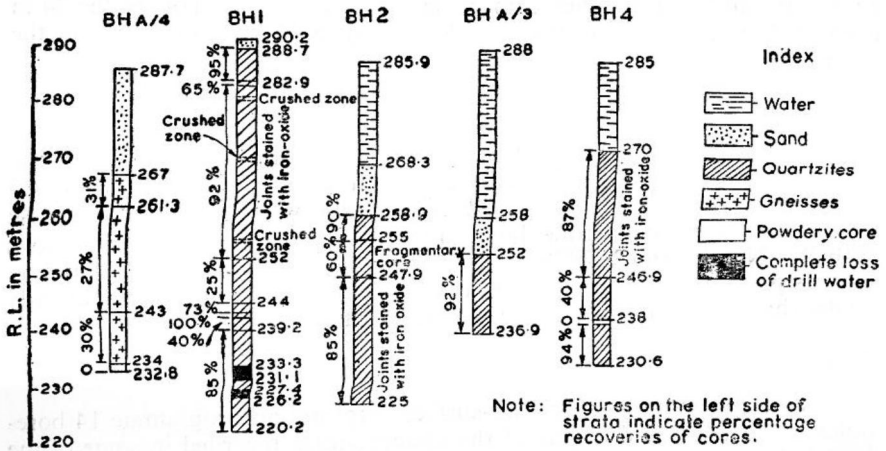
During the preliminary sub-surface exploration programme 14 bore-holes were drilled and inspite of the abnormalities recorded in some of the bore-holes, the Basal quartzite at the dam site was described as sound and unbroken. In this connection the results of the five bore-holes, namely A/4, A/3, 1, 2 and 4 (Figures 2 and 4) are noteworthy. The bore-hole Nos. A/3 and 2 are located in the deeper portion of the pool and the overburden of sand met with was 6.3 m and 9.3 m respectively. In bore-hole No. A/4 highly broken and weathered rock have been met with below 21 m of overburden throughout its length. In bore-hole No. 4 at depths of about 49 m, the core was recovered in the form of powder and fragments, while in bore-hole No. 1, there was complete loss of drill water at depths of about 57 m. Such bore-hole features are characteristic of a shear zone or a fault zone.

FIGURE 4 : Bore-hole logs showing crushed zones at Bansagar Dam site.
