Some Challenging Geotechnical Problems in River Valley Projects in India*

Y.K. Murthy**

*Second IGS Annual Lecture delivered on the occasion of its 21st Annual General Session held at University of Roorkee, Roorkee, on 21 December 1979.

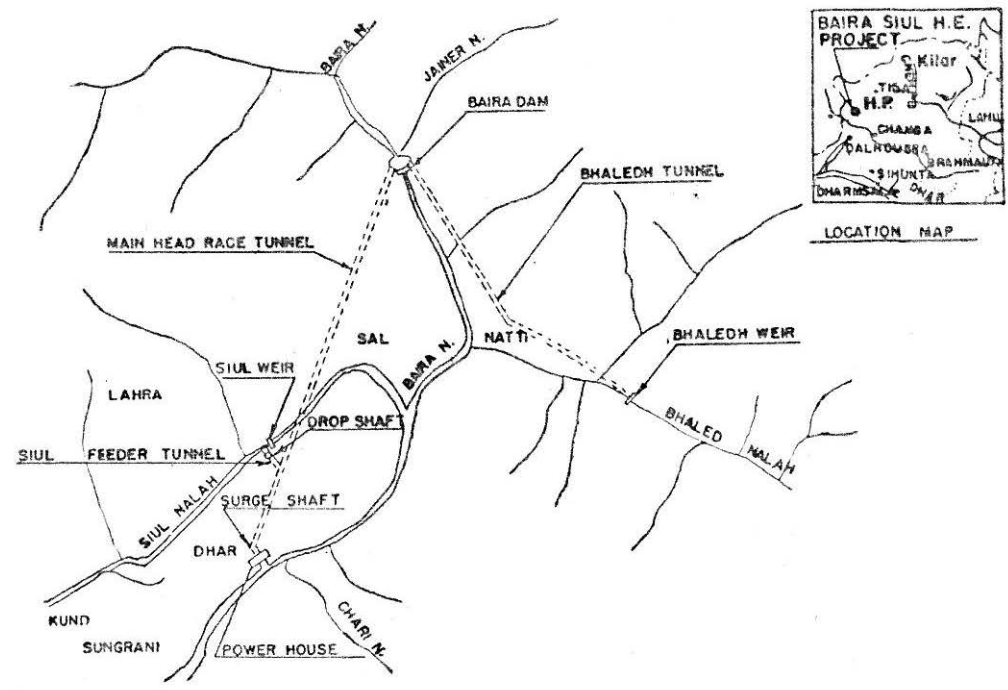
FIGURE 1 Layout plan of Baira Siul Hydro-electric Project

- (i) the hill slope consisting of debris overlying the phyllite rock above the power house is unstable. Heavy landslide occurred in the year 1976 bringing large mass of debris and filling up the power house area under construction.

- (ii) in the year 1978 another large scale landslide occurred on the right bank hill slope just downstream of the proposed axis of the Baira Dam. The landslide filled up the river bed by about 10 m. along its lengths upstream of the dam axis.

- (iii) after a heavy downpour in March, 1979, the slump movement which had occurred in the previous year had extended towards the upstream in the overburden on the right side abutment hill of the Baira Dam. The zone of the movement extends up to approximately the point above the power intake structure of the Head Race Tunnel. A problem had arisen whether to shift the intake portion upstream to a stabler location. A detailed study of the contour of the slump area was made and was found that the present position is more appropriate and was retained with some protective works.

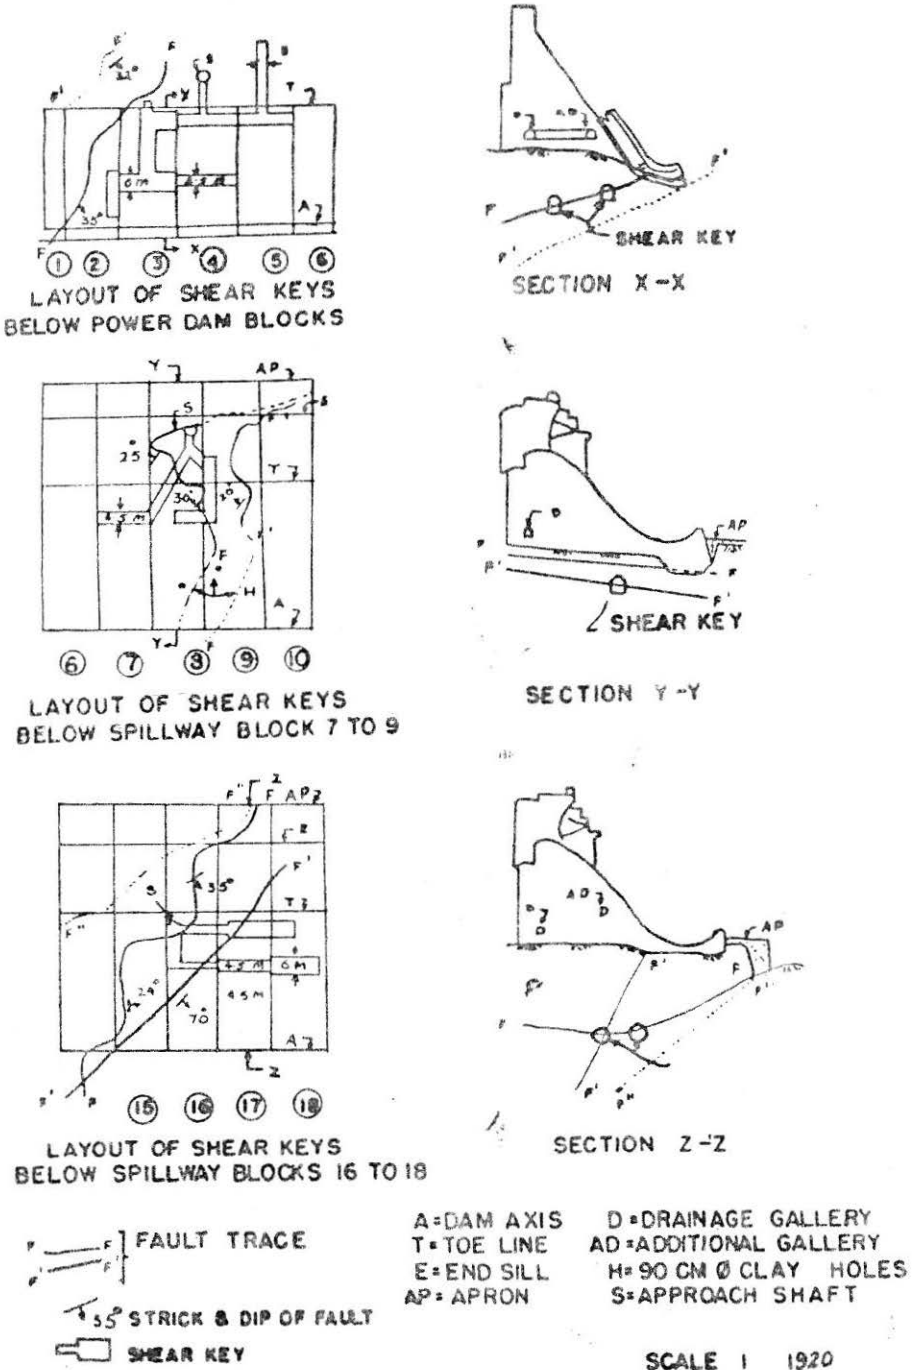
FIGURE 5 Shear keys for treatment of low angle faults below foundations of Kadana dam

The general geology of the dam site comprises quartz-mica-schists, mica-schists and phyllites. A number of faults have been encountered below and final foundation grade of the blocks, which are present in almost all the blocks of the gravity dam. The faults have a general dip towards the right bank as it continues towards the right abutment and they are met at deeper and deeper levels. The fault zones consist of clay and braccia and other fractured materials and vary in thickness from 10 cms to 40 cms. In the tranverse direction, the fault is continuous from upstream to downstream of the dam section. The materials of the shear zones have very low shear properties and therefore the zones present potential sliding planes, Sliding analysis on these blocks have shown very low shear friction factor of safety against sliding. An earthquake acceleration of 0.1g has also been considered in the stability analysis. In order to improve the resistance, shear keys were required to be provided intercepting the shear fault planes. A number of drifts had to be excavated in such a way that they will extent at least 1 m. both on top and bottom and sound rock. They are back filled with concrete to form shear keys. The total length of the drifts provided in all the dam blocks is about 300 m.

In addition to the provision of drifts, the following measures are adopted :

- (i) provision of upstream impervious blanket about 60 m width with a minimum thickness of 2 m. along the entire length of the masonry dam.
- (ii) as there was fractured rock above and below the fault plane, it was necessary to wash and grout the rock through the drifts.
- (iii) in order to have adequate grouting and drainage additional galleries downstream of the upstream gallery have been provided.

With this treatment, the safety against sliding has improved to the desired and acceptable value.
