Short Communication

Analysis of Collapse of a Building

N.V.R.L.N. Rao

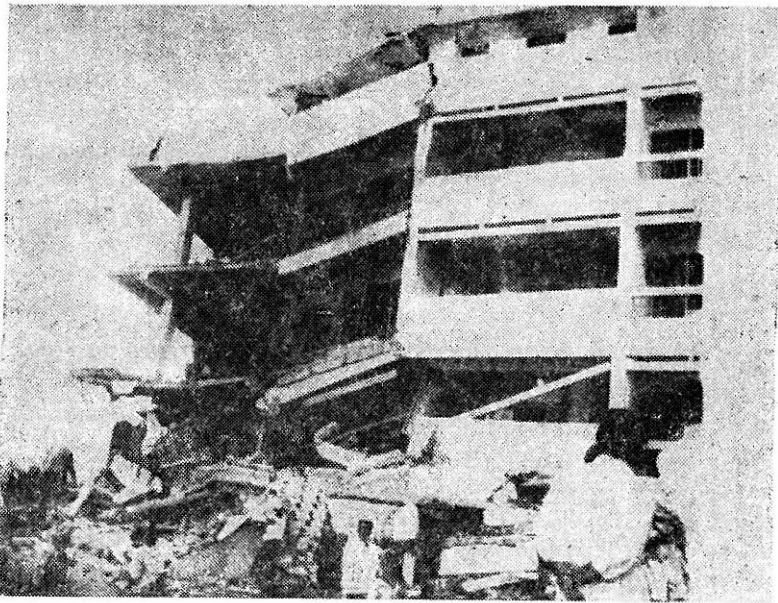
FIGURE 5 Building after Collapse (Eastern side)

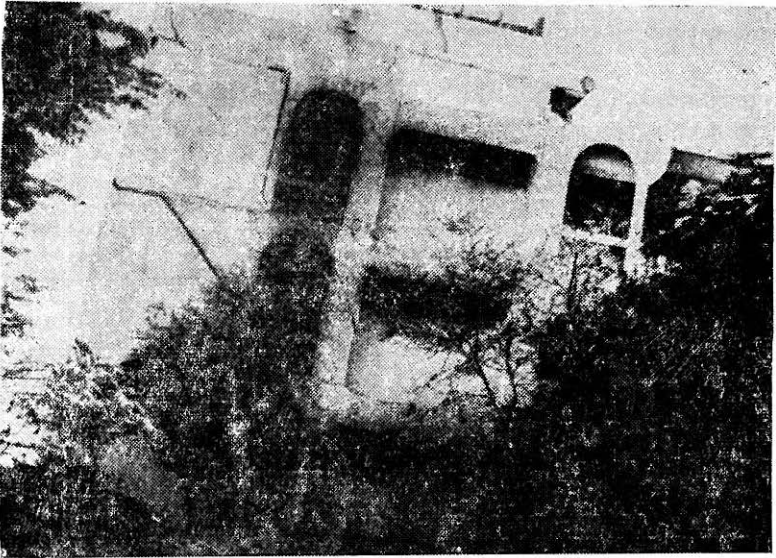
FIGURE 6 Building after Collapse (North-West corner and North face)

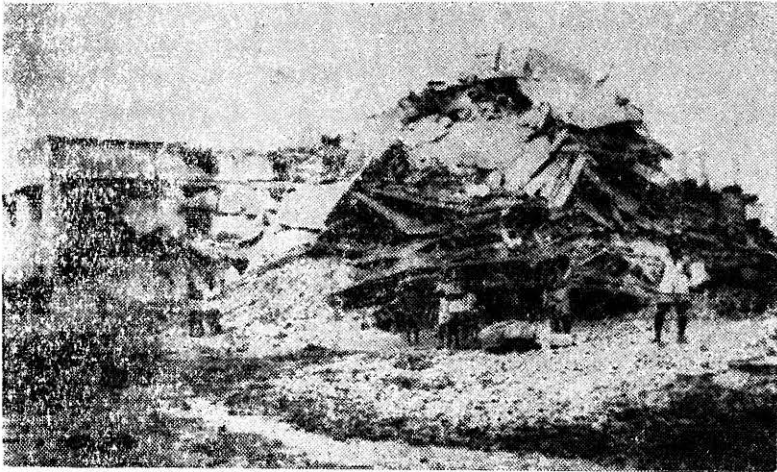
FIGURE 7 Building after Demolishing the Structure and the Neighbouring Structure on which Collapsed Building Leaned.

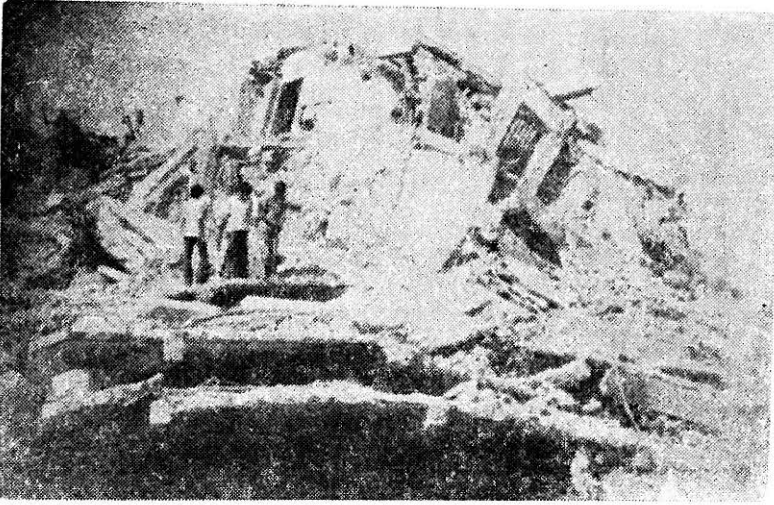
FIGURE 8 South-East Side of the Collapsed Building

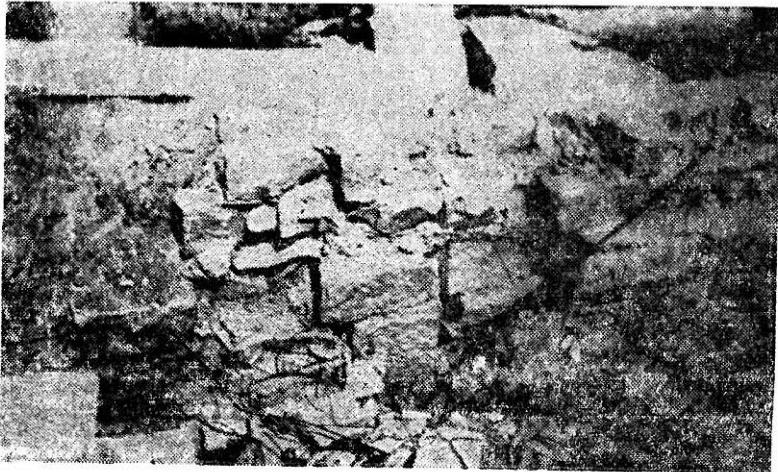
FIGURE 9 Punching Action of Column Through Pile Cap.

Primary cause of collapse of the building is liquification of top sandy clay adjoining storm water drain underneath the building which could not effectively discharge the rain water and resulted in tilt of piles towards the drain. This tilt is accentuated by the overhead water tank in the region of drain. Since the bottom soil was hard enough, vertical settlement of piles was not possible. Loss of lateral support due to liquification resulted in tilt of the piles initiating instability and insufficient thickness of pile caps (around 45 cm) resulted in punching shear (secondary cause) leading to total collapse within minutes like a pack of cards.

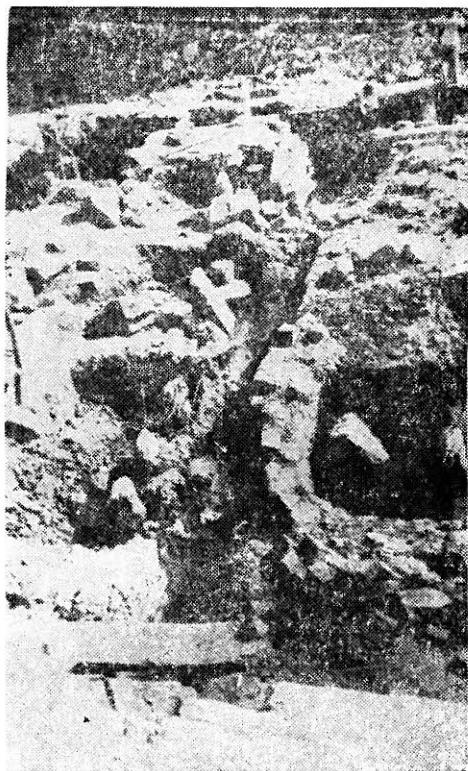
FIGURE 10 Deformed Drain, Piles and Columns below the Collapsed Building

collapse and rested on neighbouring building which has not damaged much. Portion of drain below the overhead water tank deformed in the form of bowl as illustrated in Fig. 4. Close examination of cleared site which is depicted in the form of photographs establishes the fact that the primary cause for collapse is existence of drain underneath the building and liquification of sandy clay over hard stratum due to heavy rain preceding the collapse. This conclusion is further strengthened due to the fact that other buildings in the complex built by the same organisation under identical conditions except the absence of drain did not show any distress. At present, they are all occupied. However, subsequent to collapse of foundation of building A, buildings B, C, D and G were strengthened by enlarging the ground floor columns with additional reinforcement upto ceiling and increasing the thickness of pile caps and providing inter-connecting beams to pile caps and columns.

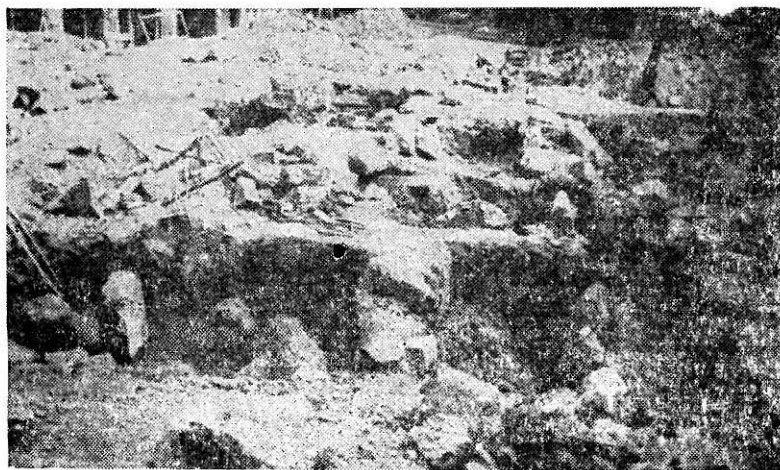
FIGURE 11 View of the North-West Column which Punched First through Pile Cap and Piles and Adjoining Drain Beneath the Building.

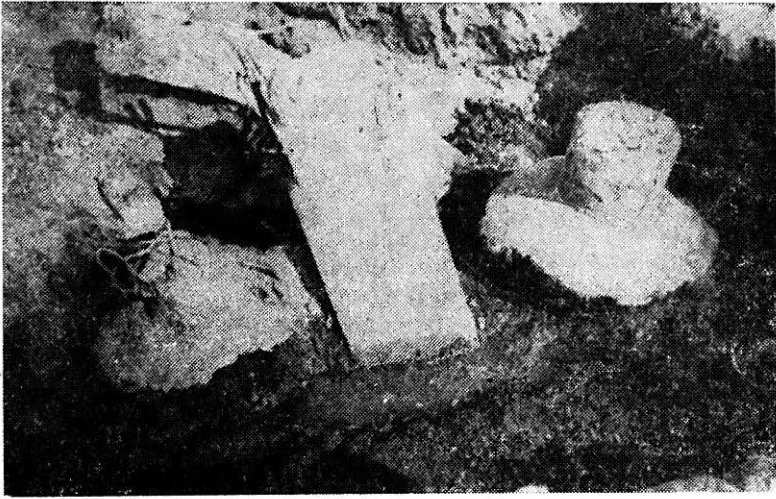
FIGURE 12 Configuration of Three Piles and Column by the Side of Drain after Collapse Indicating Pile Inclination Towards Drain and Column Inclination Away from the Drain.

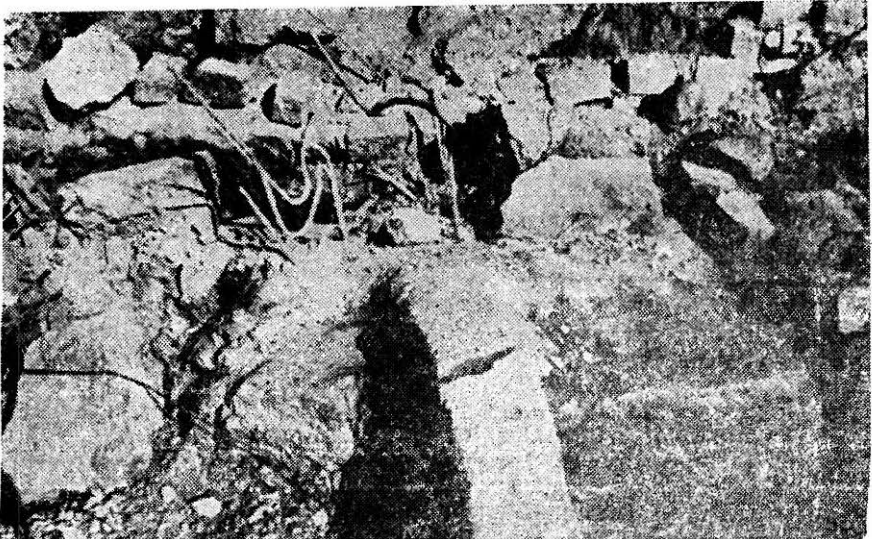
FIGURE 13 Cracking of Pile Cap Connecting Beam Supporting Office Wall which Crumbled First.

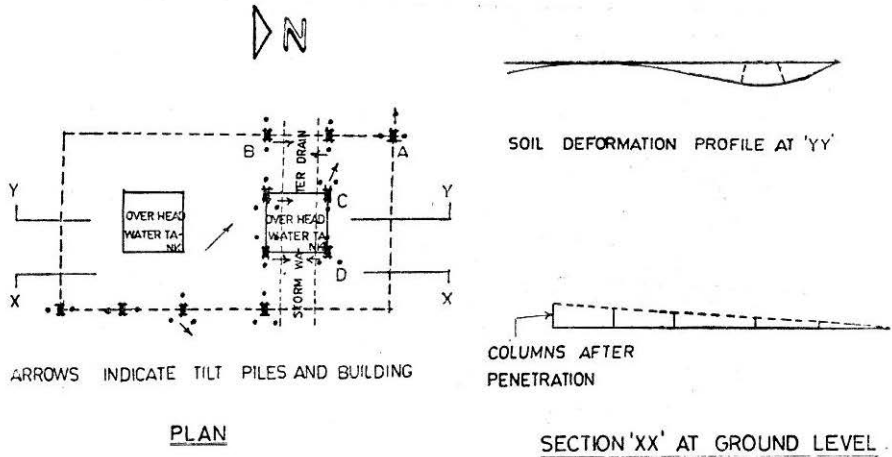
FIGURE 14 Tilt Direction of Piles and Building and Soil Deformation Profile.

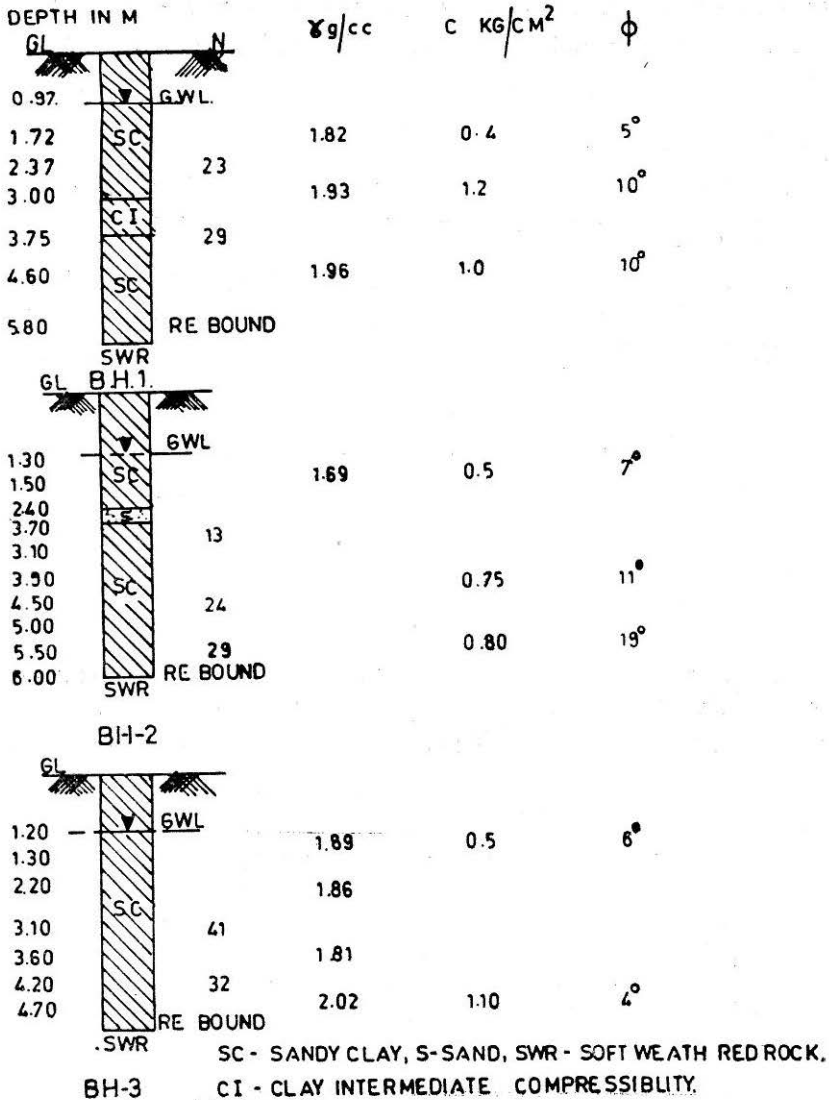
FIGURE 16 Log of Boreholes.

that the hard strata is met with between 5 to 6 m below ground level. Soil above hard strata is sandy clay having low shear strength. Bore hole No. 2 indicates existance of sand layer between depths 2.7 and 3.4 mm below the ground level. This is the region where initiation of failure of building took place one day earlier by way of falling of plaster of ground floor partition walls.

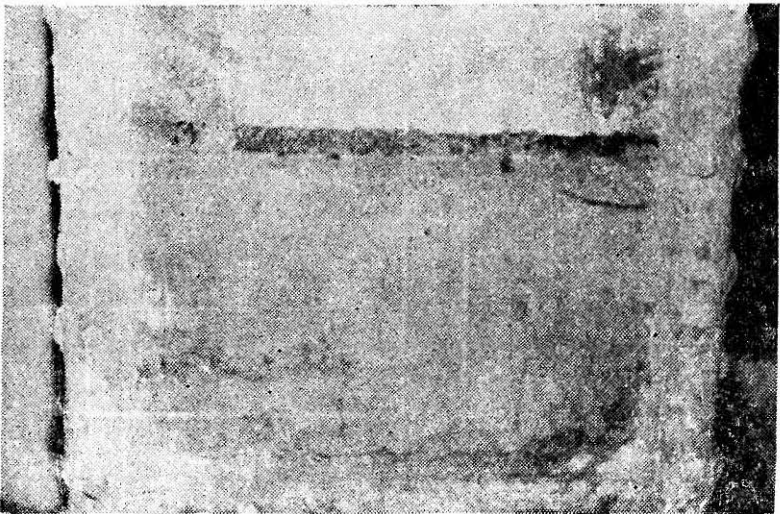
occurrence of liquifaction due to saturation. Figure 18 indicates disturbance of soil under hydraulic pressure causing liquifaction.

FIGURE 18 Soil Disturbance and Movement When Liquified in the Model.
