Damages to Buildings Due to Trees

N.V.R.L.N. Rao*

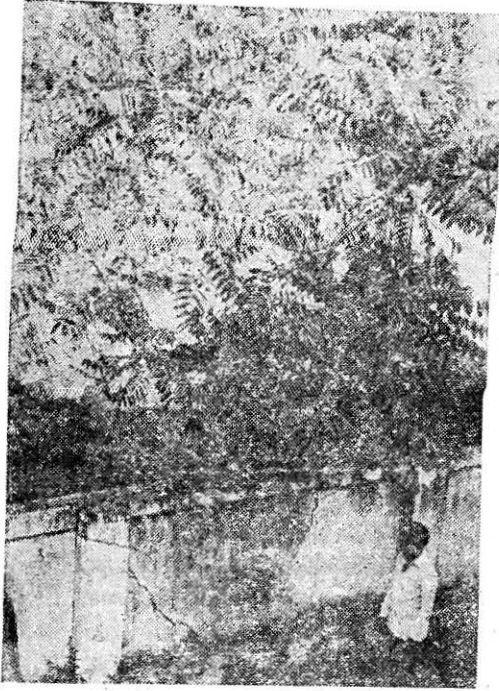
Cracking of a compound wall due to growth of a tree is illustrated in Fig. 1 and Fig. 2 from either side of the wall. Tree is named *Ailanthus Excelsa* Roxb botanically. In english it is known as Tree of Heaven. Locally it is called Maha nim or Maha rukh. It is a very fast growing tree. What is seen in the figure is third growth in four years *i.e.* it was after first appearance of cracks twice. In fact it was not planted but it grew by natural process *i.e.* its seeds might have been carried by birds and deposited through excretion at the place. In otherwords it was a natural growth.

FIGURE 1 Cracking of Compound wall due to uplift pressure of roots in hard soil

Cracking pattern is V shaped resulting upward movement of cracked portion. It shows that roots of the tree as they grow exerted upward pressure analogous to swelling pressure of clay and damage is resulted. Author has observed that the same species of tree grown very bulky but did not cause any damage to two storey building in similar soil conditions. It is because the upward pressure of the tree roots is countered by the weight of the structure.

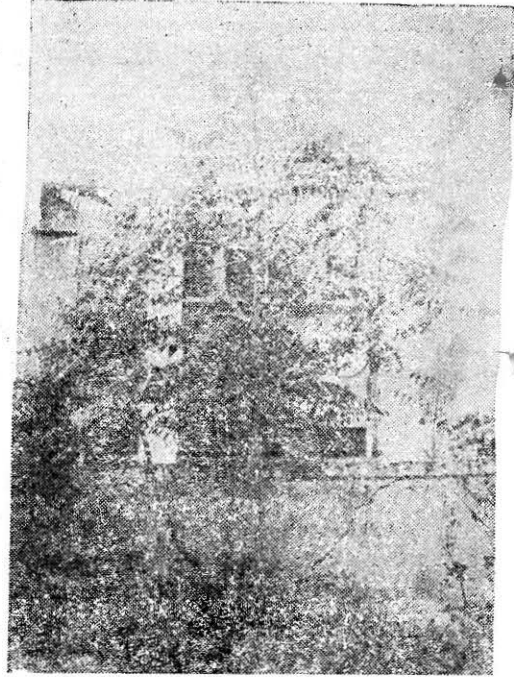
FIGURE 2 Cracked Compound wall of Fig. 1
Viewing from other side

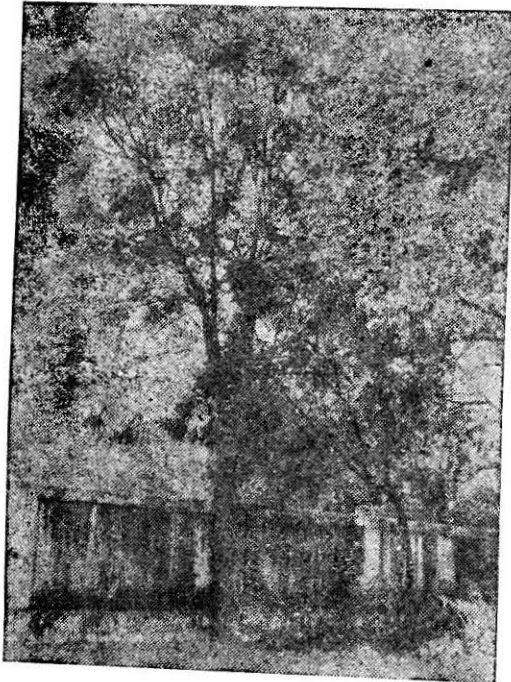
FIGURE 3 15 year old neem tree in the same Compound
with no cracks yet developed

Fig. 3 shows a 15 year old neem tree in the same compound causing no cracks yet though there are symptoms of upheaval at the base of compound wall. It is because the rate of growth of neem tree is very slow and obviously appearance of cracks also delayed. There are many other type of trees adjacent to some compound wall grown over a period of ten years but so far no visible damage occurred. Therefore it is opined that rate of growth of tree and insufficient downward pressure is the cause for cracking of compound wall in short period.

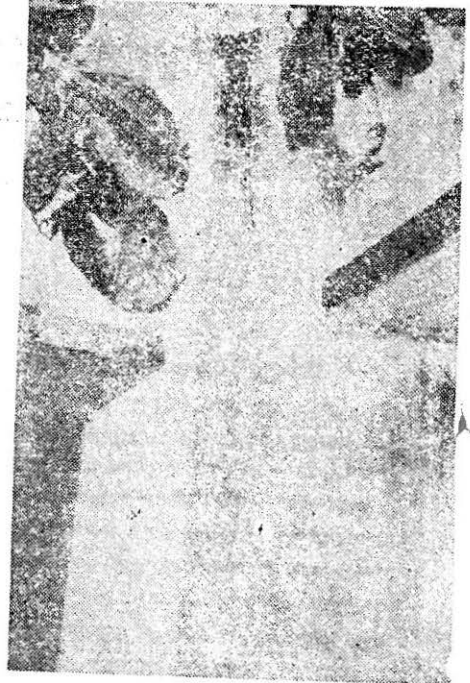
FIGURE 4 Cracks in the upstairs

Figure 4 shows cracks in the wall. Nearness of the tree from the building can be seen from the leaves of the tree. Figure 5 illustrates separation of apron from the plinth. Shadow of the tree leaves can be seen on the apron. Figure 6 illustrates the movement of water tank away from the wall at ground level. Tree is just by the side of the tank. Figure 7 illustrates severe damage to a garrage and temporary supports to roof. There are trees near the garrage.

Damages shown in Figures 4 to 7 are typical examples of many existing in the area. As can be seen soil is not expansive type. Damages are due to movement of soil while extracting water during its growth (Penchalaiah, 1986).

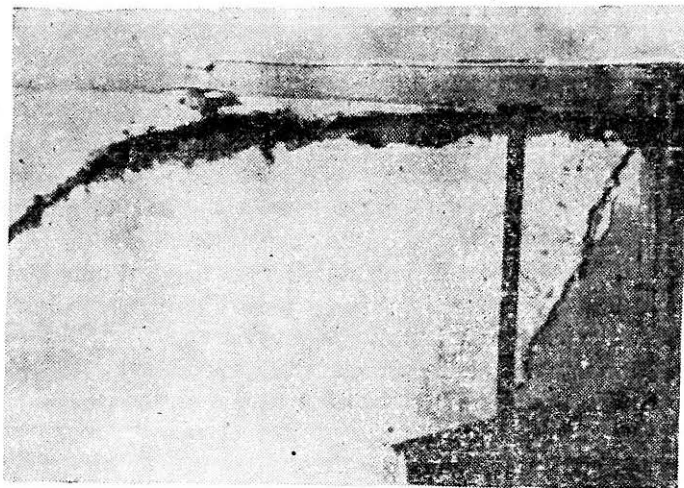
FIGURE 7 Cracks in garrage

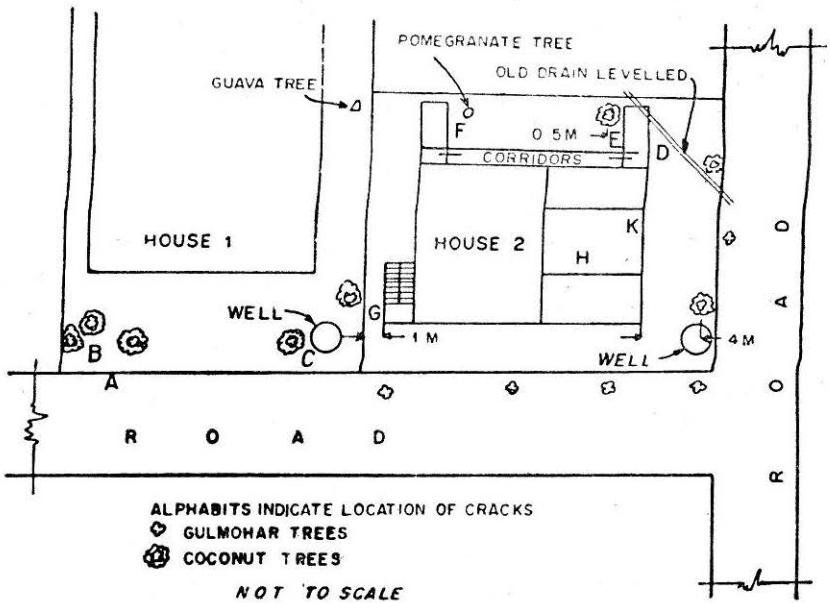
Damages to two neighbouring houses Fig. 8 in a newly built colony (16 years) are illustrated in the Figures 9 to 18. Location of trees and cracks are shown in Fig. 8. The owners with great love planted coconut trees and after twelve years following a drought year cracks became alarming. Clearance of coconut trees and few other trees surrounding the house 2 arrested the progress of cracks.

FIGURE 8 Location of trees and cracks

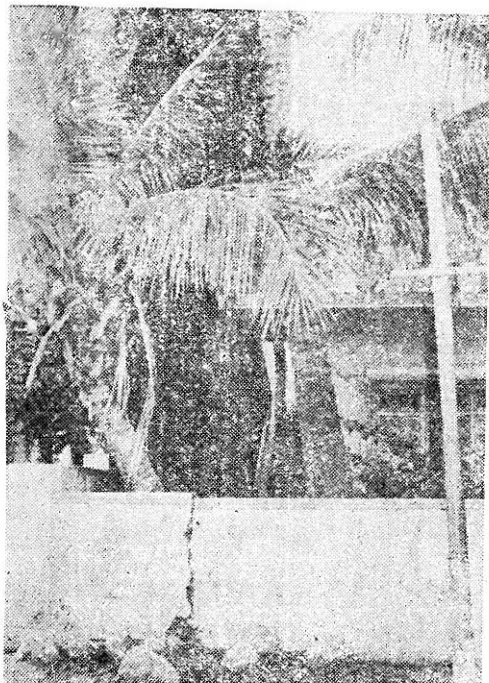
Figure 9 shows cracking and uplift of a compound wall near coconut trees at location A. Figure 10 shows cracks from inside at junction of compound walls and difference of levels in compound wall due to uplift at location B. Figure 11 shows cracks in the compound wall at location C. There are also cracks in the pan of the well.

FIGURE 9 Cracking at A

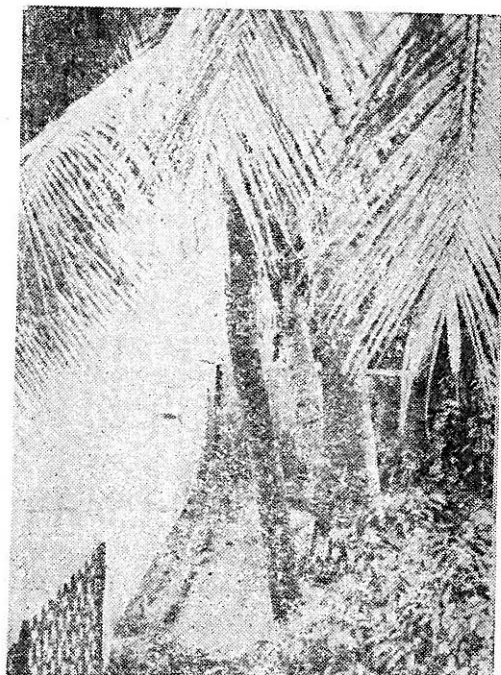
FIGURE 10 Cracks at B

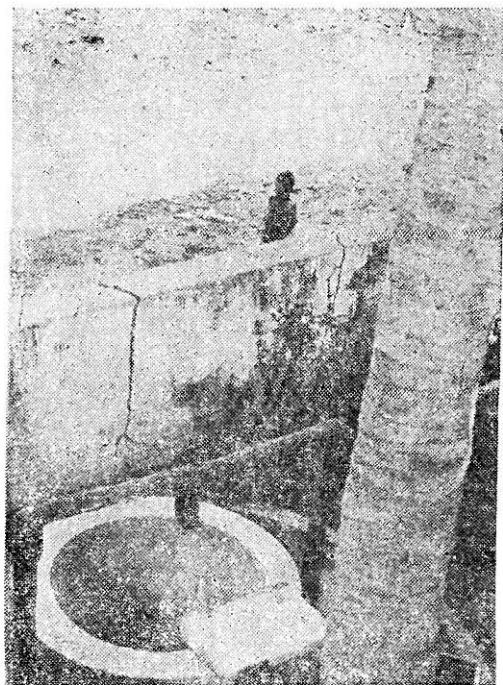
FIGURE 11 Cracks at C

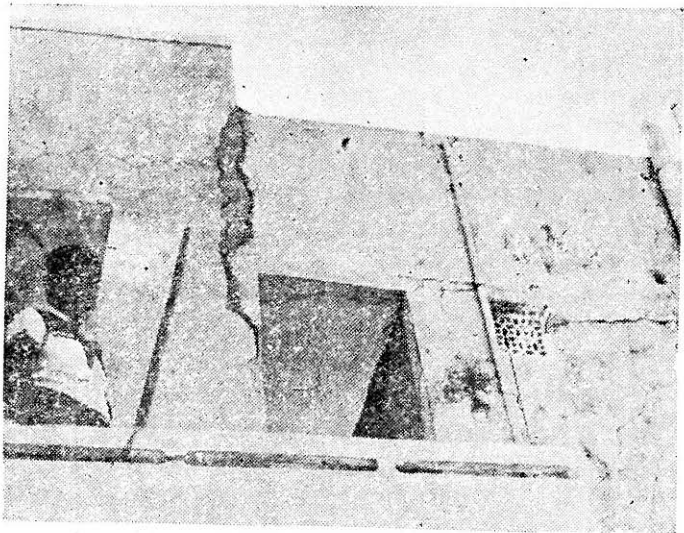
Figure 12 and 13 show cracks at location D in the ground floor and first floor of house 2. Figure 14 shows cracks in the first floor at location E. This portion of the house 2 is between two coconut trees. In this zone there was a drain which was levelled at the time of construction. Soil in this zone is black silty alluvial to a depth of 2 m. Figure 15 shows cracks

In house 2 damages are due to movement of soil due to shrinkage at locations D, E, F, H and K. At location G compound wall crack is due to uplift pressure and stair landing beam support is due to shrinkage. This shows near the trunk uplift pressure is considerable whereas at a distance where roots are thin or small in size shrinkage of soil occurs as soil moisture is absorbed. In house 1 all cracks in compound wall are due to uplift pressure caused by roots as the tree grows. Cracks due to uplift pressure of roots are in general in light structures.

FIGURE 13 Cracks at D first floor

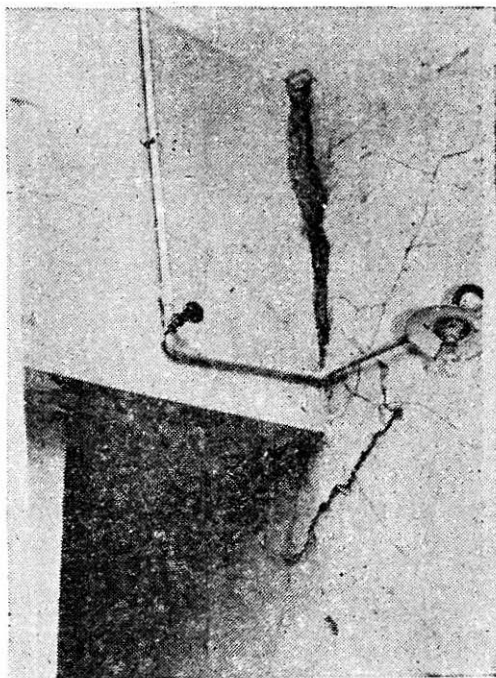
FIGURE 14 Cracks at E first floor

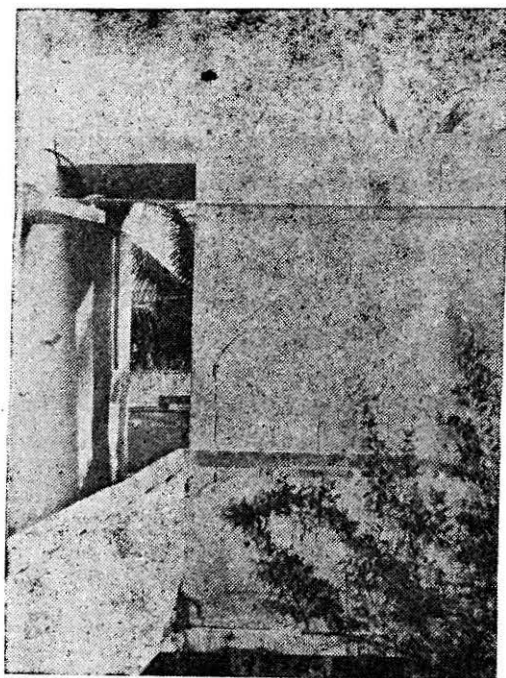
at location F. This portion of the building is located between two trees one pomegranate and another guava. There are several cracks inside and in the floor in this part of the building. Figure 16 shows cracks in the compound wall and separation of support to landing of stairs. Figures 17 and 18 shows cracks in the walls at location H and K inside the building. There are no cracks in other parts of the house 2.

FIGURE 15 Cracks at F first floor

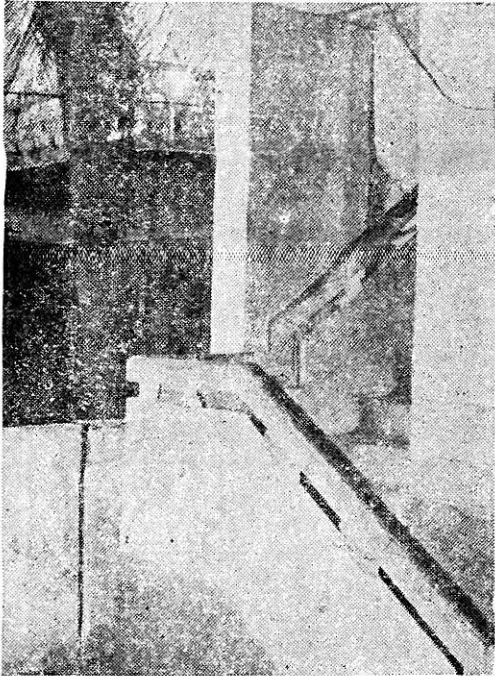
FIGURE 16 Cracks at G

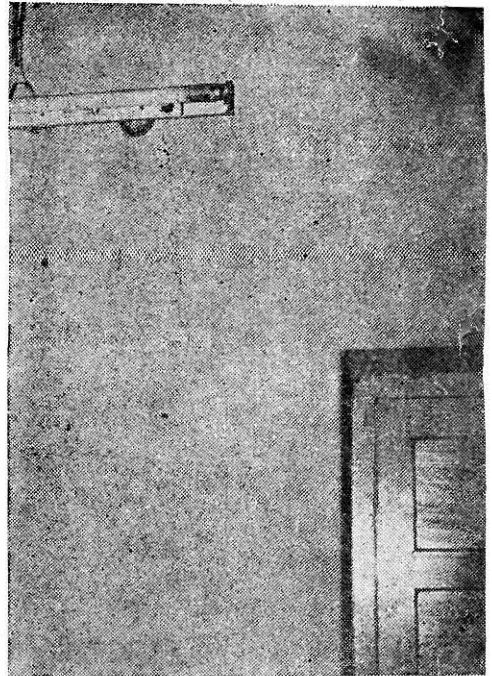
FIGURE 17 Cracks at H

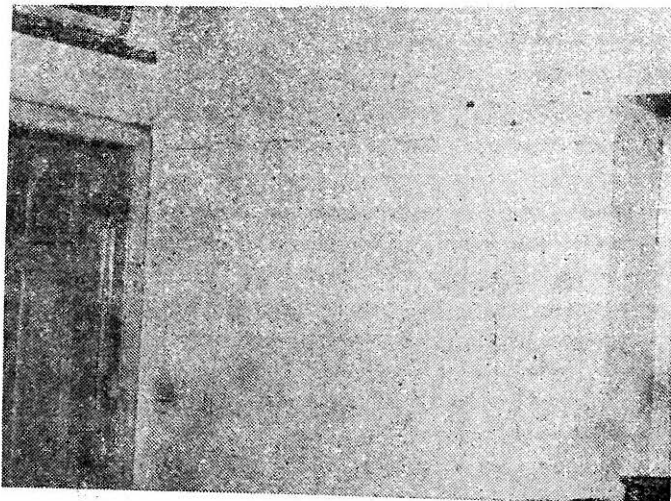
FIGURE 18 Cracks at K
