A Review of Twenty Years of Geotechnical Studies at Na'ur Landslide No. 4 in Jordan

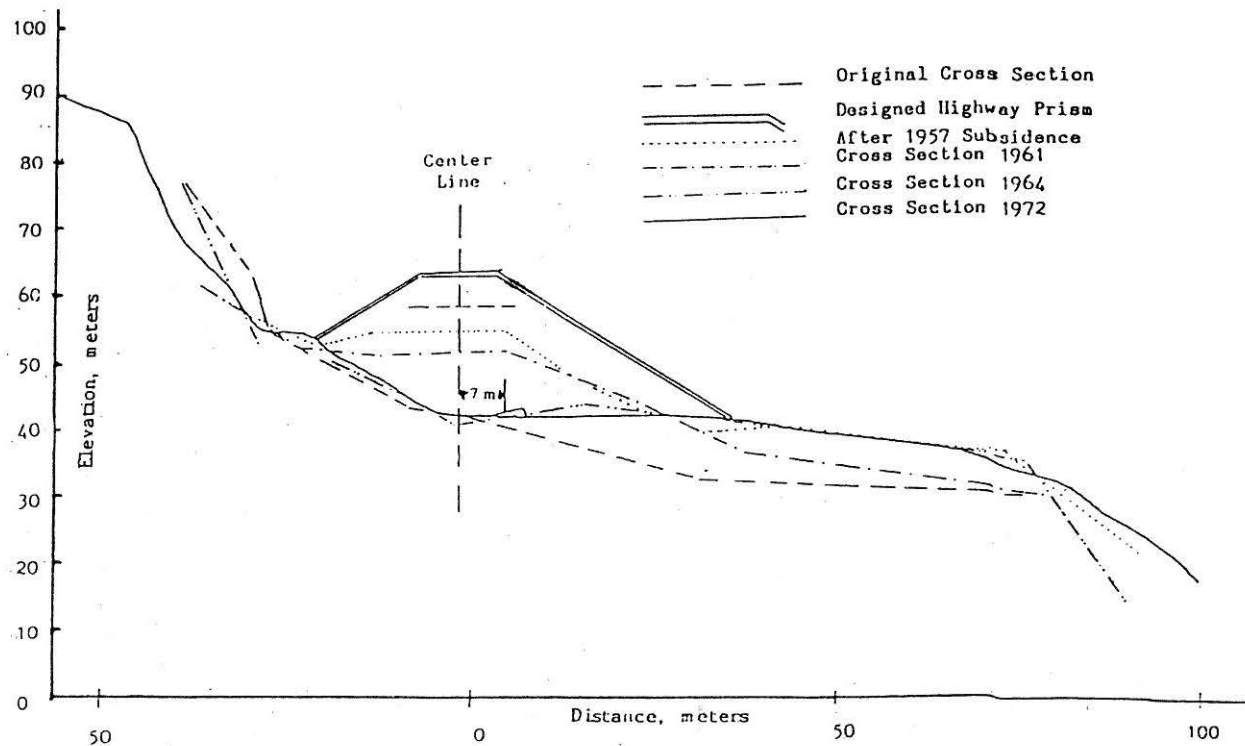
FIGURE 2 Cross Section of Different Subsidence of Na'ur Landslide No.4 During the Period (1957-1972).

1954 involved a proposed 20 m high embankment. In 1956, when the embankment was 14 m high and 200 m length, the embankment has subsided about 7 m. After reconstructing the embankment 14 m height, there was a renewal subsidence of several meters in 1957, repeated refilling eventually left the embankment at a height of 9 m and the road was opened for use in 1957. In February 1964, following a month of 141 mm of continuous heavy rainfall, the embankment suffered a 7 m vertical and 11 m horizontal slide, along a 150 m stretch. This incident resulted in the road being abandoned. Fig. 2 shows cross section of different subsidence at site of Na'ur Landslide No. 4.

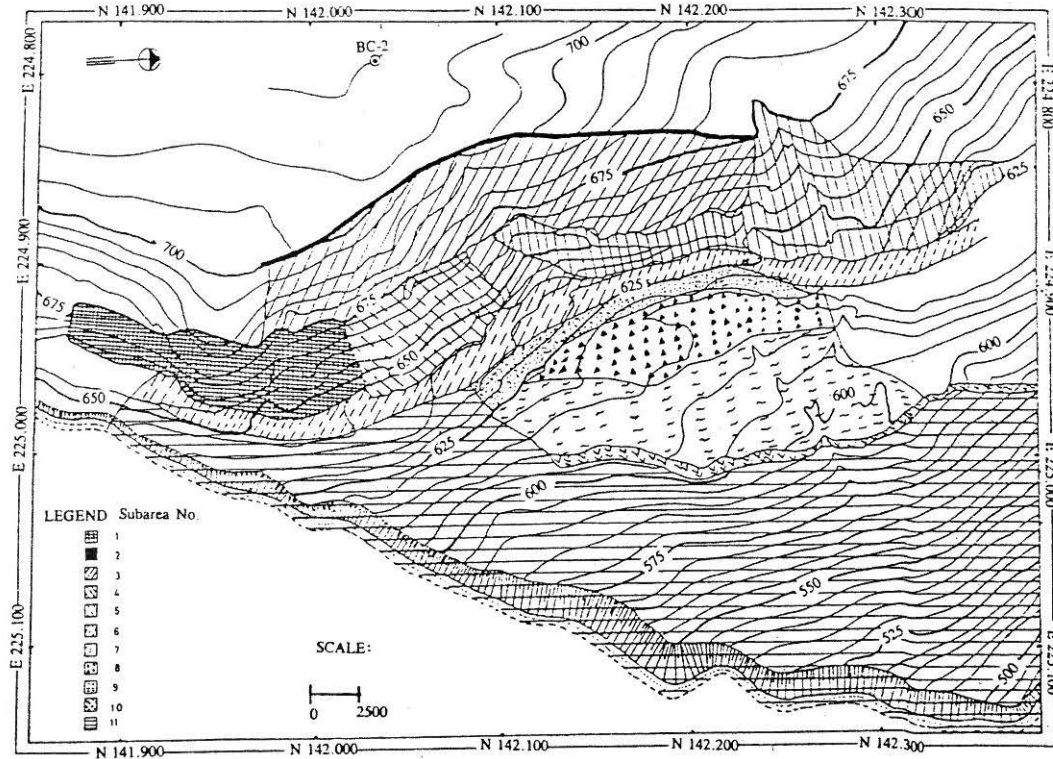
- Subarea 1 : This is the site of the limestone and marl slide forming a major gully.
- Subarea 2 : It represents the rear limestone scarp which is vertical to undercut rock face of limestone and marl.
- Subarea 3 : Immediately below the rear limestone scarp, an upper ledge is encountered. it consists of very rough, irregular terrain strewn with boulders and blocks up to 8 m × 6 m × 6 m in size. These blocks and boulders are underlain by marl.
- Subarea 4 : It comprises foundered limestone outcrops.

FIGURE 4 Geomorphological Map of Na'ur Landslide No.4.

Rocks Falls : Subarea 2 (Fig. 4) include rock fall features and cliff scarps of the limestone and the other competent beds of the Middle Cretaceous Ajlun Group A1-2 and A3 Formation. Movement of rocks in this category resulted when materials at the base of the escarpment are removed during the slide, thereby leaving the overlying rock layer unsupported. The main features characterizing the rock falls are the tensional cracks and open joints behind the cliff scarps.

Debris Falls : As in the rock falls, debris falls are present in the studied area forming escarpment of loose materials and incompetent rocks of the same mentioned formation, and in a similar mechanism. This type of movement is obviously seen in subarea 11 (Fig. 4)

Block Slides : Block slides are well established in subarea 3 (Fig. 4) of the landslide. Due to the sub-aerial weathering processes, which lead to lithification, jointing and fracturing, the rocks tend to separate into blocks and slide as units across the landslide area.

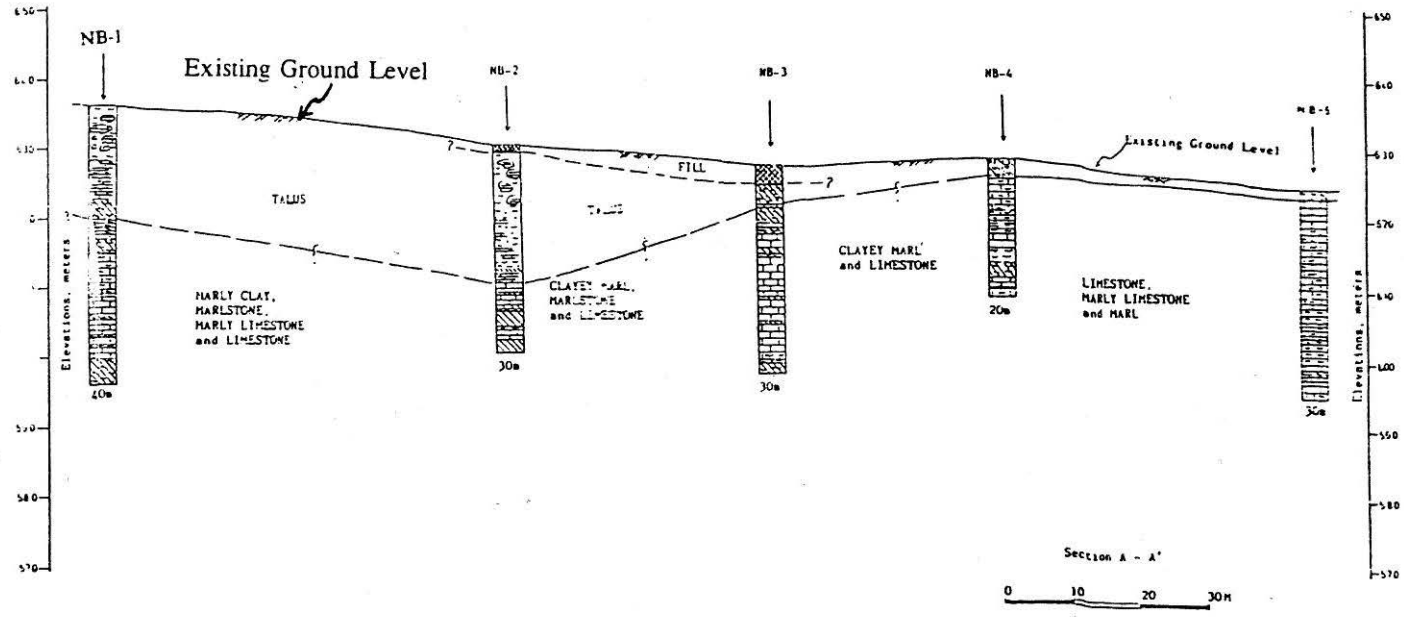
the other depending on its location in the site. These variations are shown on Figs. 7 through 10.

FIGURE 7 Subsurface Cross Section between Boreholes Drilled in Studied Area (Boreholes NB-1, NB-2, NB-3, NB-4, and NB-5,

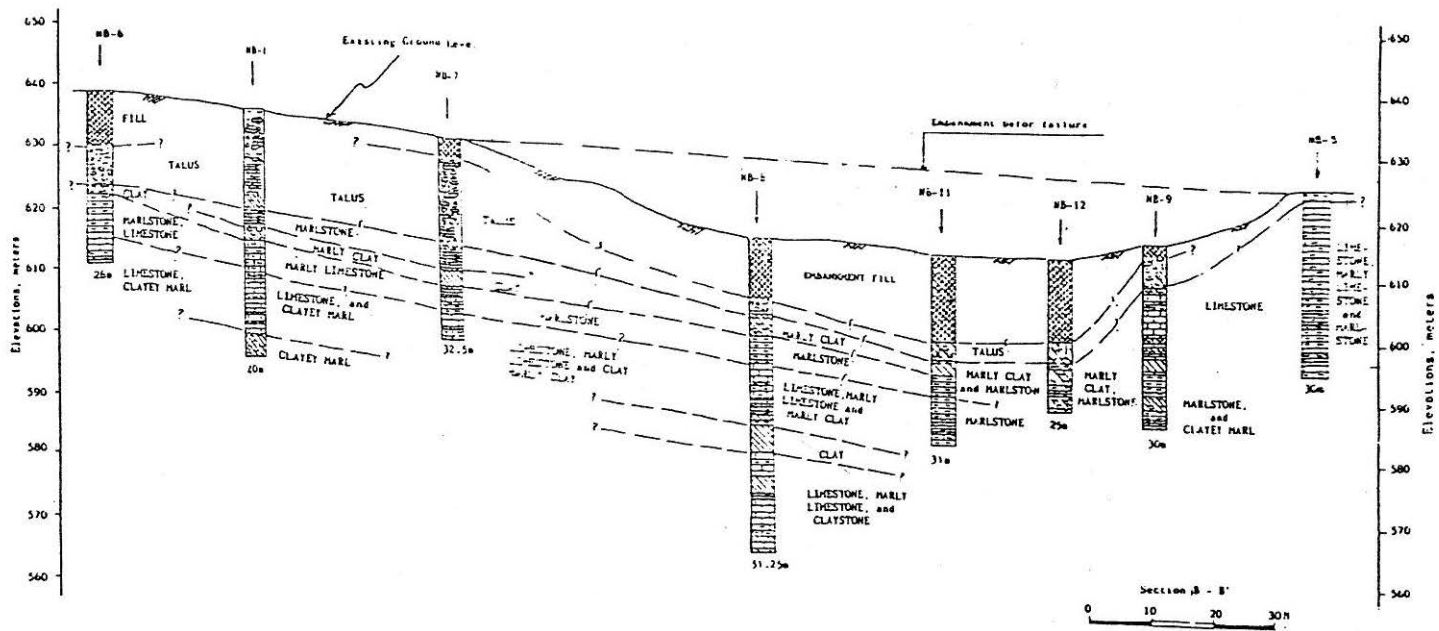
FIGURE 8 Subsurface Cross Section between Boreholes Drilled in Studied Area (Boreholes NB-6, NB-1, NB-7, NH-8, NB-11, NB-12, NB-9, and NB-5).

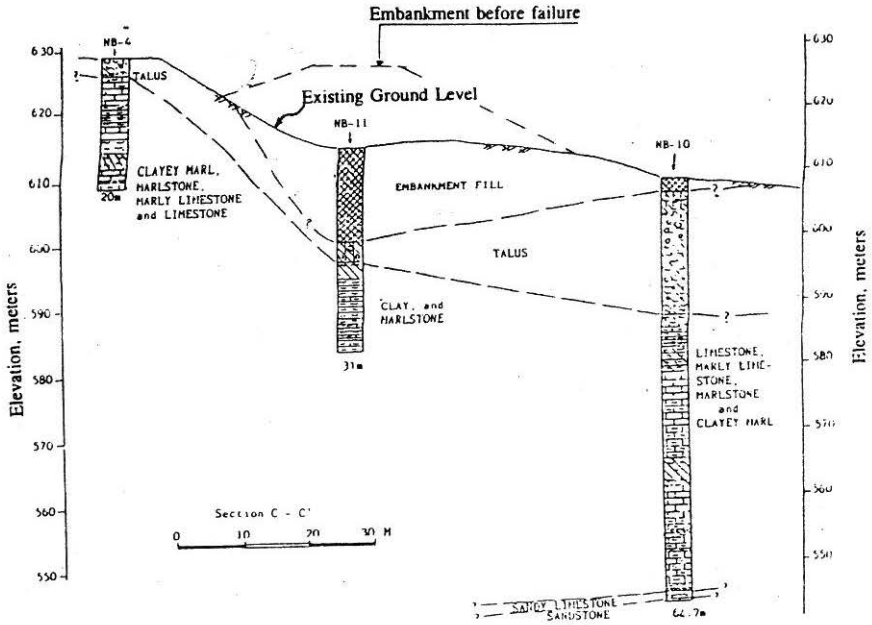
FIGURE 9 Subsurface Cross Section between Boreholes Drilled in Studied Area (Boreholes NB-4, NB-11, and NB-10).

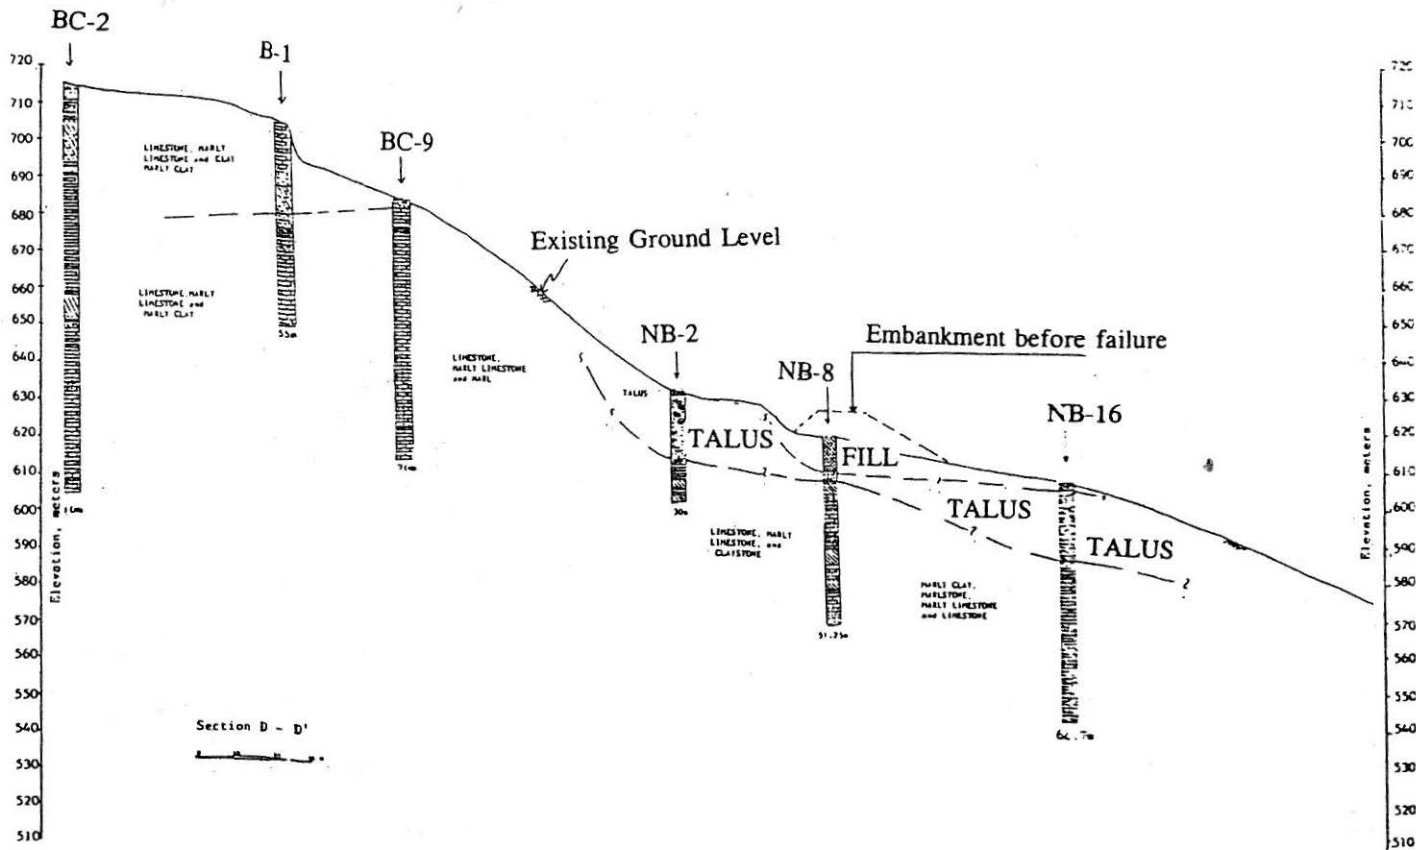
FIGURE 10 Subsurface Cross Section between Boreholes Drilled in Studied Area (Boreholes BC-2, B-1, and BC-9, NB-8, and NB-16)

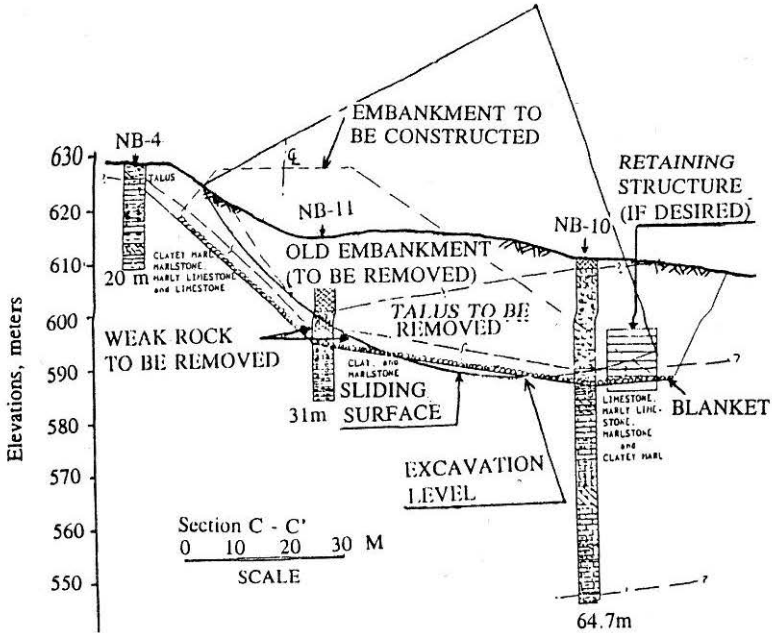
Stability analysis is carried out for the above recommended solution. The stability analysis is made using a cross-section taken through the center of the slided area, which is considered the most critical part of the slided area, where the embankment thickness will be greatest. A circular failure surface is considered through the embankment fill and tangential to the strong bedrock. Simplified Bishop method incorporates in the computer code REAME (Huang, 1983) is used in evaluating the factor of safety.

Partially submerged embankment condition is assumed in the analysis, Strength parameters used in the analysis are cohesion $c' = 0 \text{ kg/cm}^2$ and friction angle $\phi' = 35$ degrees for both the fill and the bedrock.

FIGURE 11 Recommended Solution for Road Reconstruction According to this Study (Geometry of Critical Slip Surface is also Shown).

Based on previous studies and assessment of the current condition at the landslide area, it is the authors opinion that the soft materials (fill, talus and the soft bedrock) should be excavated and removed from the landslide area to reach the solid and strong bedrock (limestones and marlstones).

Following the excavation within the slided area a free drained embankment can be constructed on the top of the strong bedrock, this embankment may consist of rockfill of limestone and marly limestones gravels and boulders compacted in layers. A free draining blanket consisting of pure rock is recommended to be placed between the bedrock and the new embankment to guarantee a good subsurface drainage.

The calculated quantities of rockfill materials needed to reconstruct this embankment along the slided area is about 500,000 cubic meters. The side slope of the embankment is recommended to be 1-vertical to 1.5-horizontal. Fig. 11 shows the details of the solutions to construct the road through Na'ur Slide Area No. 4
