## **Foundations of the Indian Museum Building, Calcutta**

**Devendra Sharma\* and D. Roy†**

### **Introduction**

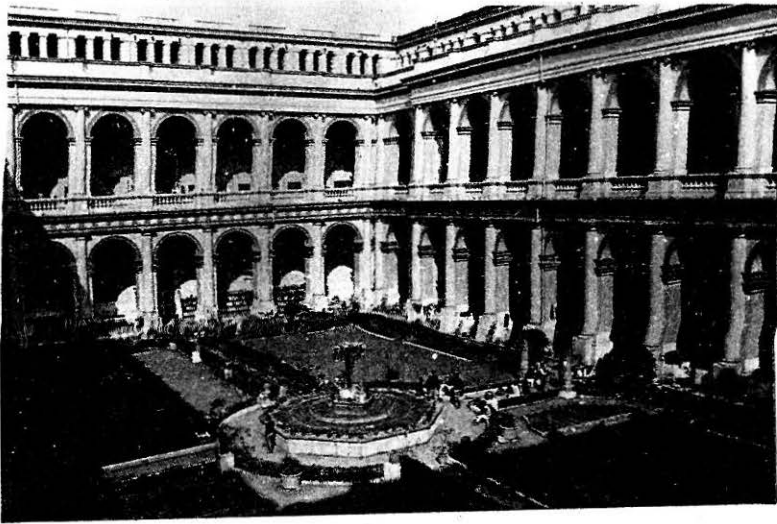
Several cracks could be observed in the walls and the arches may be due to both the deterioration of material and differential settlement. It could be noticed visually in the courtyard that the southeast and southwest corners have sunk down. The front block facing Chowringhee has settled more over the years as compared to the rest of the building as evidenced by vertical cracks wider at top in the walls of north and south blocks (Fig. 7). Loss of adhesion in the mortar, rusting of RSJs and seepage of water from roofs and fittings for sanitary and water supply and consequent adverse effects were also visible at certain locations. On account of repairs from time to time it was not possible to identify all the cracks hidden under plastering

FIGURE 3 : Central Courtyard (South-East Corner)

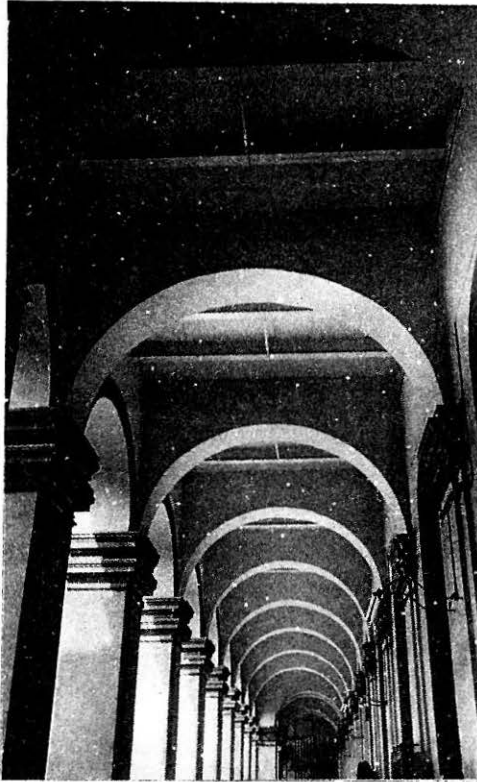
The building consists of load bearing walls and columns (Fig. 4) supporting arches and girders over the openings and for supporting the roof (Figs. 5 and 6). The outer wall is 1.4 m thick. The brick columns of different sizes have been provided. The column size in the display gallery on the eastern side is 76 cm  $\times$  76 cm on plinth of 92 cm  $\times$  92 cm. The bricks used are of nominal size 10 in  $\times$  5 in  $\times$  3 in. The brickwork is in lime mortar. The intermediate floor and roof mainly consist of thick RSJ as the main load bearing girders supporting cross T sections laid over with tiles and lime concrete.

FIGURE 5 : View of Corridor with Arches

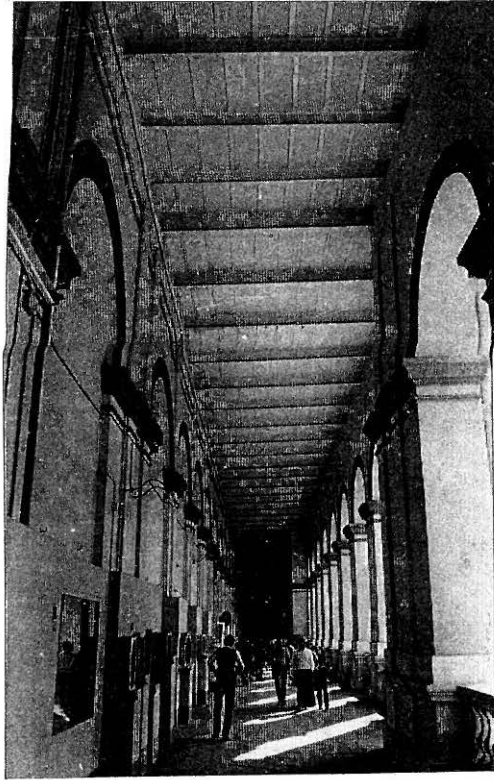
**FIGURE 6 : View of Corridor with Steel Section in Ceiling**

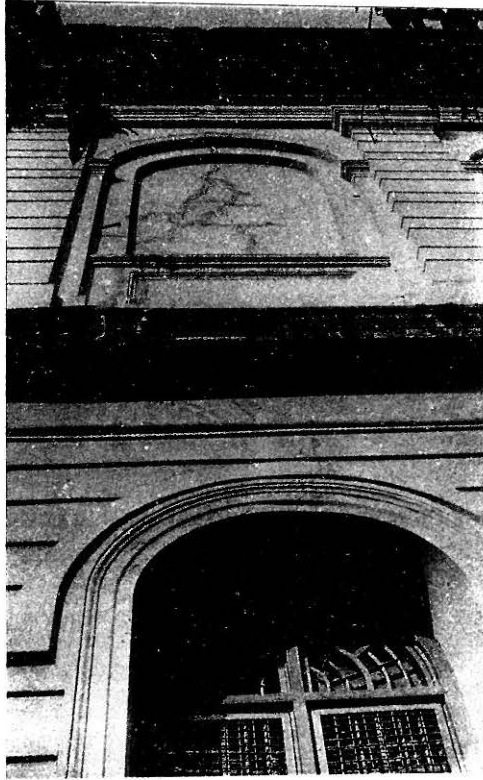
and painting on walls, however, reappearance of the cracks at some of the locations of the earlier ones indicate that cracks have been active. Cracks and distortions in some of the arches were quite obvious.

**FIGURE 7 : Crack on Southern Side Wall**

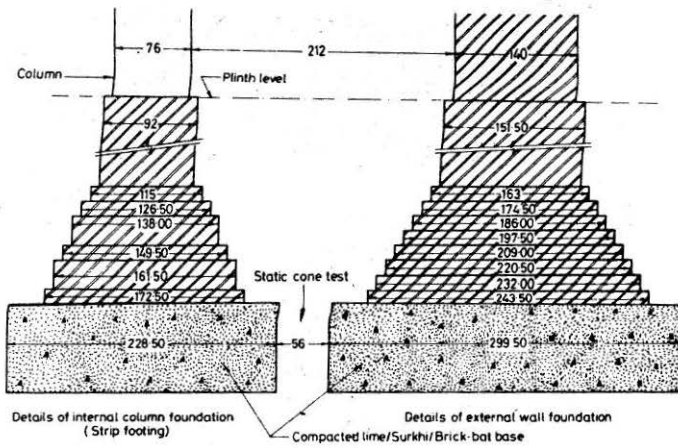
The details of the foundation confirmed by digging are shown in Fig. 8. The most striking features are their massive nature, great depth and close proximity of 0.56 m clear distance between the two strip footings. The depth

below the plinth, which is of varying height above the present ground levels, is 3.72 m. It seemed that ground level had been raised above the original level.

FIGURE 8 : Details of Strip Footings (Section A-A)

The row of 76 cm × 76 cm columns at 4.64 m spacing is supported by 2.20 m width strip footing. The outer wall of 140 cm is on 3 m width strip footing. The estimated loads show that the pressures at base of the inner strip is  $3.68 \text{ t/m}^2$  and at the outer one  $22.38 \text{ t/m}^2$ . The difference between the two pressure intensities is very striking. One major factor for this situation is the massive outer wall of 140 cm thickness. What was the basis of foundation design and their peculiar feature of close proximity at 56 cm clear distance defies a rational explanation. Obviously the bearing capacity, if it was a consideration, was taken about  $22.5 \text{ t/m}^2$  for the outer wall footing.

The footing widths seem to have been decided by keeping the offsets such that the general slope from the plinth base is at about 1 : 2 (IS:1904-1973). Intensity of pressure does not seem to be guiding factor for their width and large variation in loading at two adjacent footings seems to have been ignored. On account of the erratic nature of strata, it is difficult to assign specific soil parameters for bearing pressure calculations. Generalised penetration resistance values seem to be better guide. Both the footings are of the same depth and quite close to each other (Fig. 8). They can be considered to act together, and averaging out of the minimum static cone penetration test values can be done within a depth 1.5 times their combined width. Silt fraction predominates in soil and clay is also present. The soils have a cohesion value of less than  $0.5 \text{ kg/cm}^2$ . For reducing static cone penetration resistance value to standard penetration N value a conversion by making them one third (Sanglerat, 1972) gives a N value of about 4. These values indicate a soil on low bearing capacity (IS:6403-1981). The estimated value of safe bearing capacity for the present under water conditions are well below  $10 \text{ t/m}^2$  (Peck et al., 1974). The loading intensity of  $22.38 \text{ t/m}^2$  at the outer wall footing base is in excess even by bearing consideration. The settlement considerations also are to permit still less value of allowable bearing pressure (IS:8009-1976).

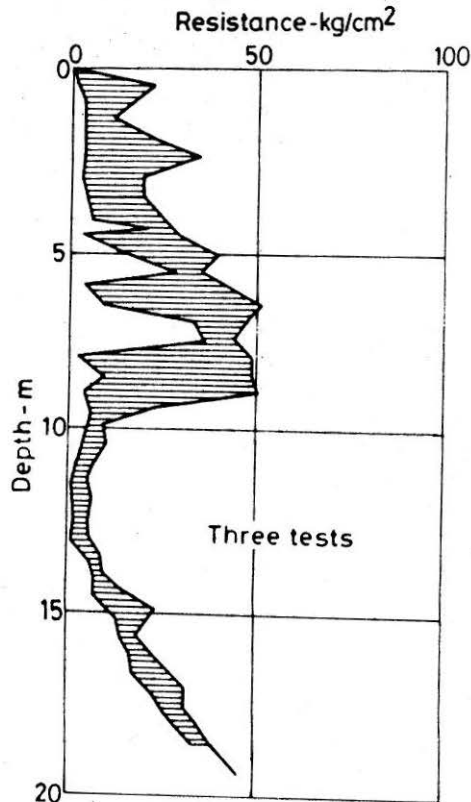
The range of variation of resistance for three penetration test curves is shown in Fig. 9. The available strata details from the adjacent site did not show well defined uniform layers; however, a generalised sequence was top fill of clayey silt of 0.5 to 5.0 m thickness followed by sandy and clayey silt of 2 m to 5 m thickness followed by sandy and clayey silt of 2 m to 10 m thickness, followed by clayey silt with decomposed wood 3 m to 6 m thick and below it layers of silty clay with kankar and clayey silt with sand. The thickness variation in layers was rather erratic. The same might be the situation for the building site under reference. The strata as revealed by digging the pit in gallery is shown in Fig. 10. The site of the museum building is flat land. Geologically the strata are alluvial deposits of the Gangetic plains. Occurrence of stratum consisting of decomposed wood is typical of Calcutta deposits (Dastidar and Ghosh, 1984) . It is generally of

FIGURE 9 : Penetration Resistance with Depth

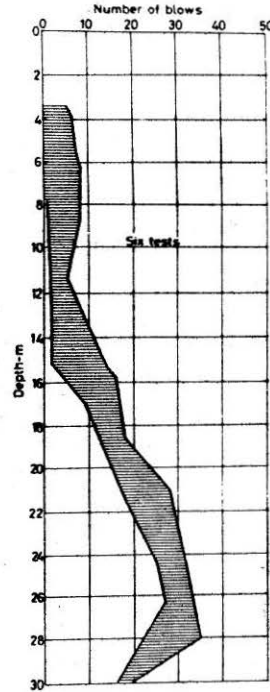
low 'N' value within 10. This strata corresponds to depths between 10 m to 15 m (Fig. 11) showing very low penetration resistance. Strata between about 5 m to 9 m is of better but erratic resistance. The foundations are resting on this strata of varying resistance.

FIGURE 11 :  
Penetration Resistance with Depth
