Identification and Location of Slide Prone Areas in Certain Hard Rock Profiles of Western Ghats

R. Krishnanath* and S. Sreekumar†

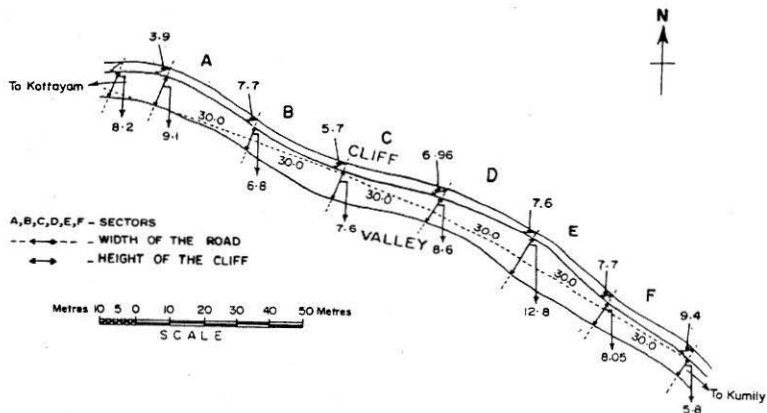
FIGURE 2 : Schematic of the Profile.
A, B, C, D, E and F are Sectors

FIGURE 2 : Longitudinal Profile of the Road Cut Cliff.
A, B, C, D, E and F are Sectors

is 750 m. The entire profile is divided into six sectors : A, B, C, D, E and F. All the sectors are of length 30 m (Fig. 2 and 3). Vegetation is sparse on the cliff.

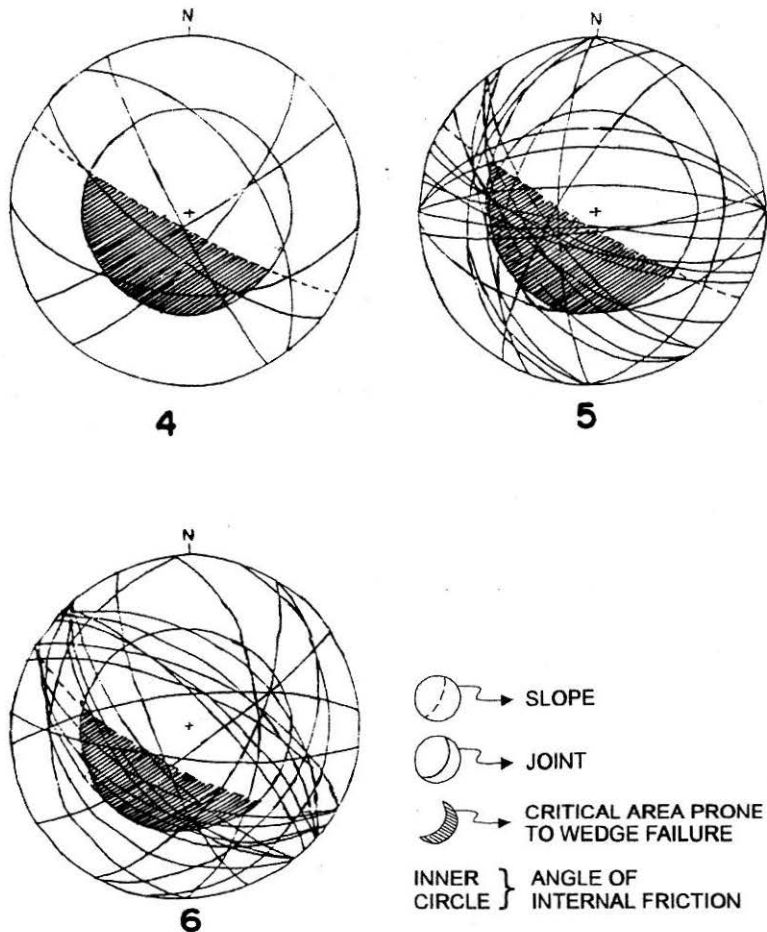
FIGURE 4 to 6 : β Diagram for Sectors A, B and C. Broken Arcs are the Traces of Slopes, the Inner Circles are the Angles of Internal Friction for the Materials, Crescent Shaped Shaded Areas Represent the Limit for Wedge Failure Caused by Intersection of Joint Planes

The length of the sector (Fig. 3) is 30 m and the height of the cut cliff is 3.9 m. The natural slope of the hill is 70° N 210° and the cliff slope is 82° N 210° . The first figure is the inclination of the slope or any plane with the horizontal and the second figure is the direction of the slope/dip in the azimuth from North in a clockwise direction. There are six major joints in the sector. Probability for the occurences of the wedge and overhanging plane failure is identified from diagram (Fig. 4). Factor of safety of the slope of this factor is one, when the rocks are dry. During rain storms water seeps through the discontinuities and in the presence of water along these joints, factor of safety may be further reduced to 0.65. The approximate quantity of material that may be wasted is calculated by estimating the volume of the free body from geometric constructions. On the basis of a conservative estimate, assuming that the joints do not propagate much into the rocks, the weight of potential debris is estimated at 31500000 kg. However, a detailed field investigation revealed that the joints persist and propagate far into the rockmass, thereby increasing the volume of the free body with a consequent increase in weight to 775297000 kg. Types of probable failure, factor of safety and free body weight are stated in Table 1.

Length of the sector is 30 m. The height of the cut cliff is 7.6 m. The natural slope is $75^\circ \text{ N } 210^\circ$. The cliff slope is $84^\circ \text{ N } 210^\circ$. The major rock type is granitic gneiss. There are nineteen joints in the sector. Wedge failure and toppling are probable in this sector (Fig. 5). The amount of debris that may slide is estimated as 490000 kg. Factor of safety is less than one even when the rock is dry (Table 1).

This sector has a length of 30 m and the height of the cliff is 5.7 m. The slope is $72^\circ \text{ N } 210^\circ$. Granitic gneiss is relatively fresh and unaltered. Eighteen joints occur in this sector. This sector is prone to wedge failure, toppling failure and over hanging plane failure (Fig. 6). Factor of safety is below one. The amount of material that may slide is determined at 384000 kg (Table 1).

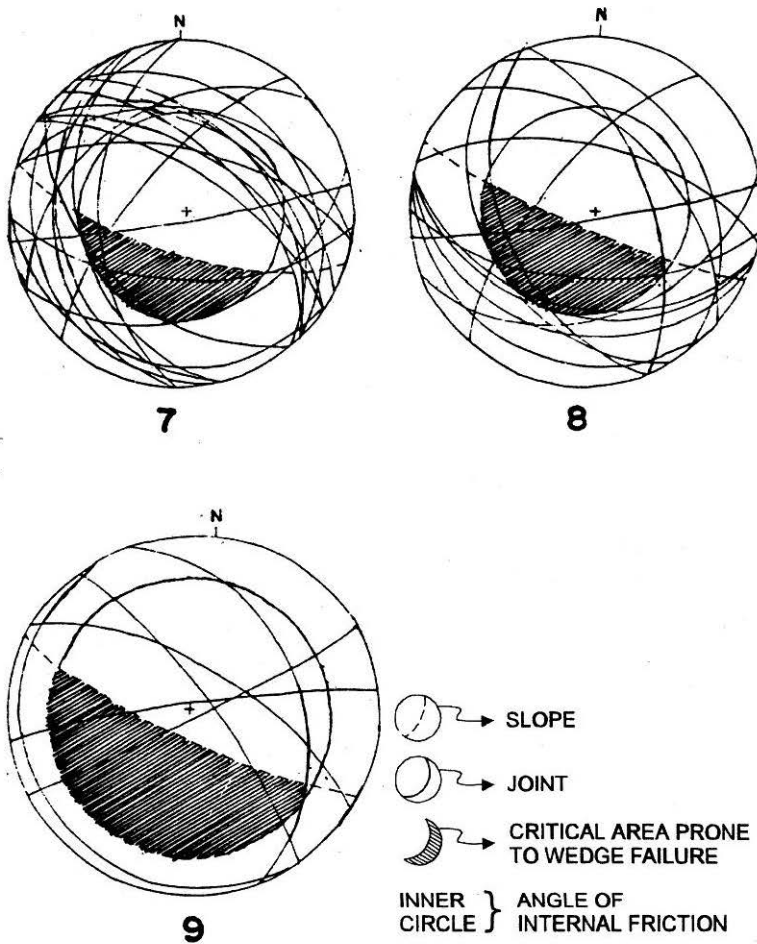
FIGURE 7 to 9 : β Diagram for Sectors D, E and F. Broken Arcs are the Traces of Slopes, the Inner Circles are the Angles of Internal Friction for the Materials, Crescent Shaped Shaded Areas Represent the Limit for Wedge Failure Caused by Intersection of Joint Planes

The total length of the sector is 30 m and the cliff height is 6.96 m. The natural slope is 76° N 210° and road cut slope is 70° N 200°. Charnockite with fresh blue quartz and feldspar is the rock type. There are eighteen joints present in this sector. Sector is prone to wedge and over hanging plane failure and is unsafe even during dry condition (Fig. 7). The amount of material that may be wasted is estimated at 1622000 kg (Table 1).

Sector E is 30 m long and the cliff height is 7.6 m. Seventeen joints are observed in the sector. Natural slope is 70° N 210° and cliff slope is 81° N 200°. Wedge failure and toppling can occur in this sector (Fig. 8).

Sector is unsafe and the amount of material that may slide is estimated at 10692000 kg (Table 1).

Length of the sector is 30 m and the height of the cliff is 7.7 m. The cliff slope is 80° N 200° and natural slope is 70° N 210° . The main rock type charnockite is highly weathered. Only six joints are observed in this sector. All the joints are dipping away from the cliff slope (Fig. 9). These joints are filled with mineral infillings and therefore, probability for toppling occurs only at a minimum level (Table 1).

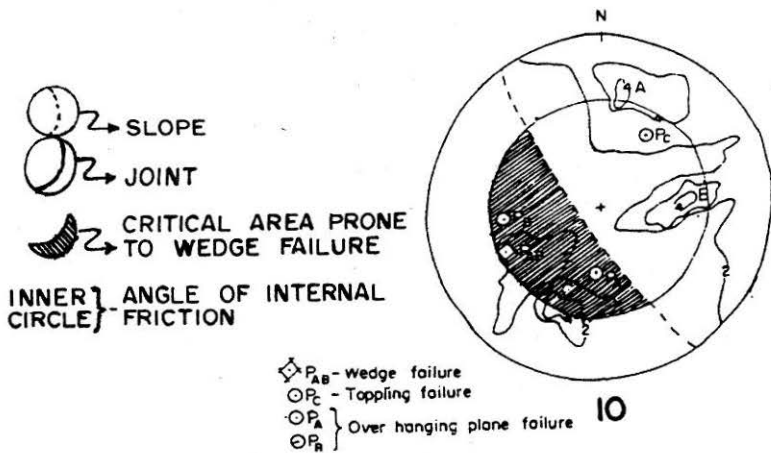
FIGURE 10 : π Pole Diagram for Peermode Profile. A, B and C are the Maxima of the Poles of the Joint Planes.

π Pole diagram has been constructed (Fig. 10) for perspective analyses of the discontinuities geometrically. A, B and C are the maxima of the poles of the joint planes. P_{AB} which falls in the crescent shaped shaded area is the pole to the great circle connecting the maxima A and B. This indicates the probability of wedge failure along the Peermode profile, in general P_C is the pole to the great circles passing through the maxima C. This is located diametrically opposite to the great circle for the slope indicating the probability for toppling failure. P_A and P_B are poles to the great circles passing through the maxima A and B respectively and these are located in the shaded area of the projection indicating the probability for overhanging plane failure on a perspective basis.
