Slope Instability in the Fragile Himalaya and Strategy for Development*

by
R. K. Bhandari**

* Ninth IGS Annual Lecture delivered on the occasion of its 28th Annual General Session held at New Delhi, India.

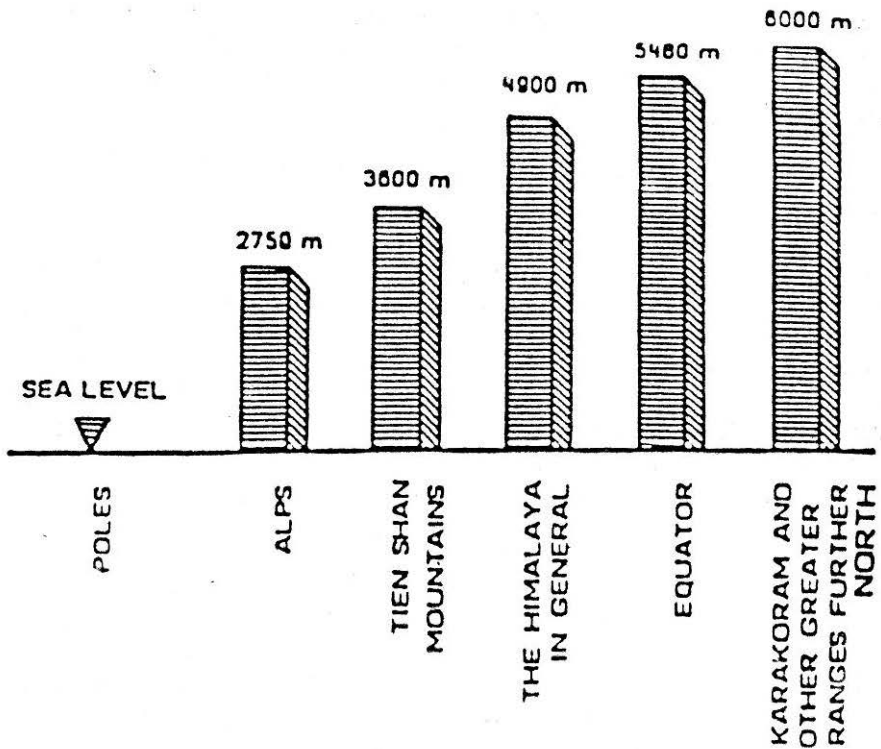
FIGURE 7 Himalayan Snow Line

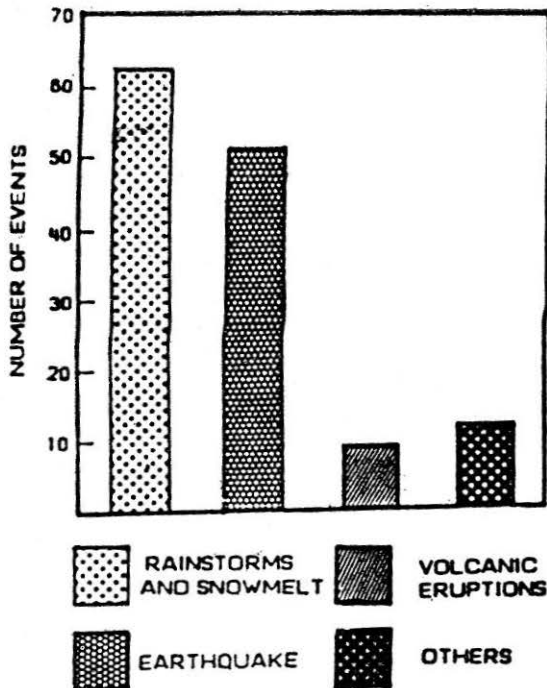
FIGURE 9 Causes of Landslides that have Formed Dams Based on 135 Cases from the Literature (Schuster 1986)

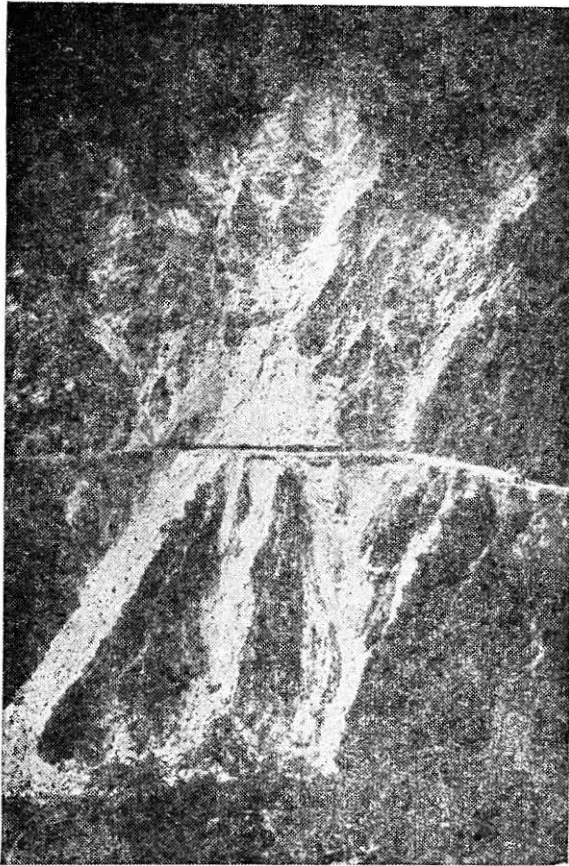
FIGURE 21 Kaliasaur Landslide on Rishikes Badrinath Road

The location has experienced a number of major landslides in 1952, 1963, 1965 and 1969. The slide of 19th September 1969 had blocked 3/4th of the width of the river flowing about 100 m below the road level. The road was badly damaged in a stretch of 300 m. The crown portion of the

slide extended nearly 120 m above the road level. The slide continued to be active over a period of two weeks. Thereafter, during 1970, 1971 and 1972 the landslides occurred again disrupting the communication system and each time new formation width had to be cut. During August-September 1984, following heavy rainfall, a major landslide occurred and damaged the road considerably, extending the rear scar of the slide retrogressively. The recent slide was in August 1986.

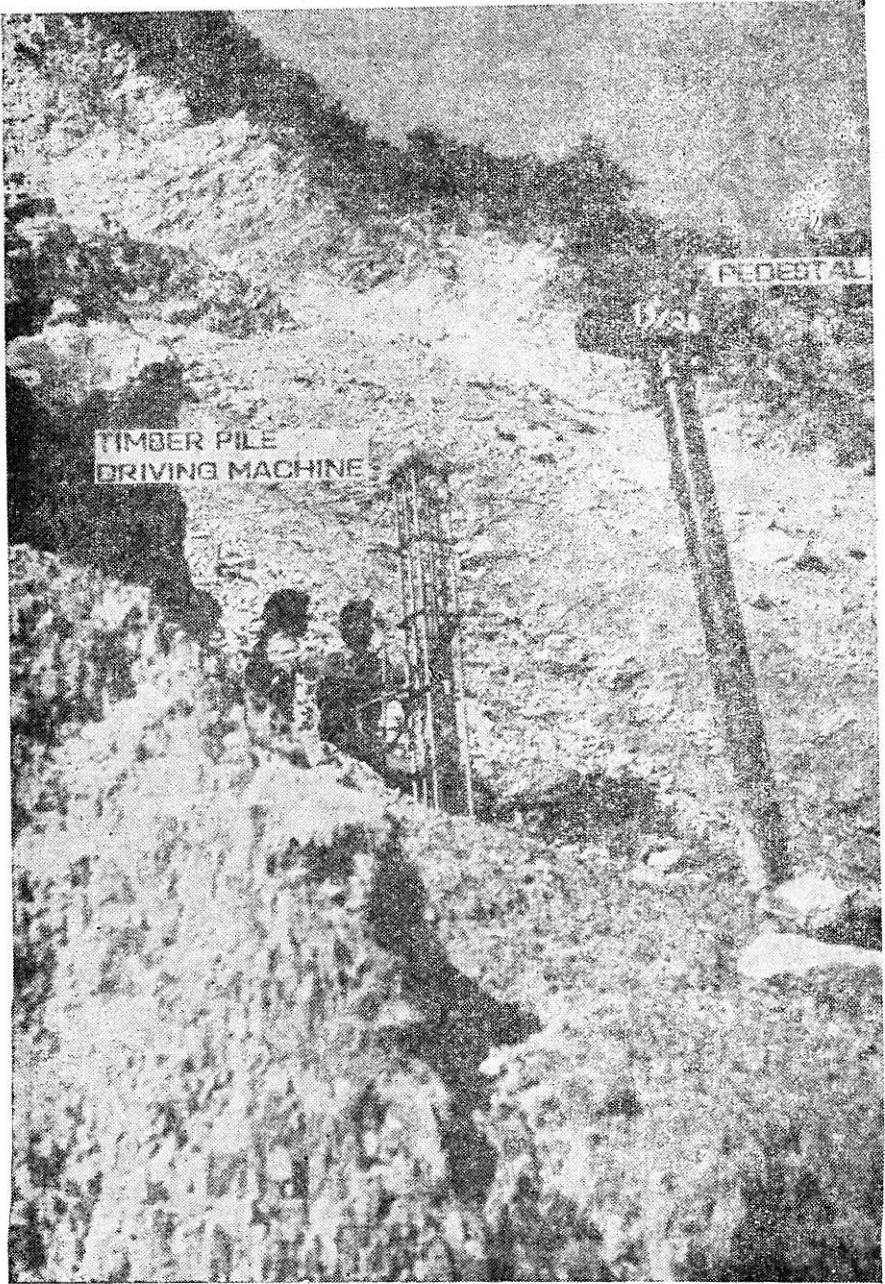
FIGURE 27 Stitch of Colluvium on the Slope at Kaliasaur by a Simple Lowcost Timber Piling Machine

Difficulties of timber piling have now been largely overcome by a new, lowcost portable timber piling machine developed at the Central Building Research Institute, Kaushish and Jain (1986), (Fig. 27). Timber piles 10 cm square from Deodar, Sheesham and Eucalyptus wood were driven in lengths of 1.5 m each suitably spliced, at six locations on the Kaliasaur

slide using the portable machine requiring only one man to operate. The 30 kg hammer used earlier is now being replaced by 50 kg hammer to achieve higher orders of driving energy.
