## **IGS - Lecture 1994**

### **Innovative Developments in Indian Geotechnical Practices**

**N.V. Nayak\***

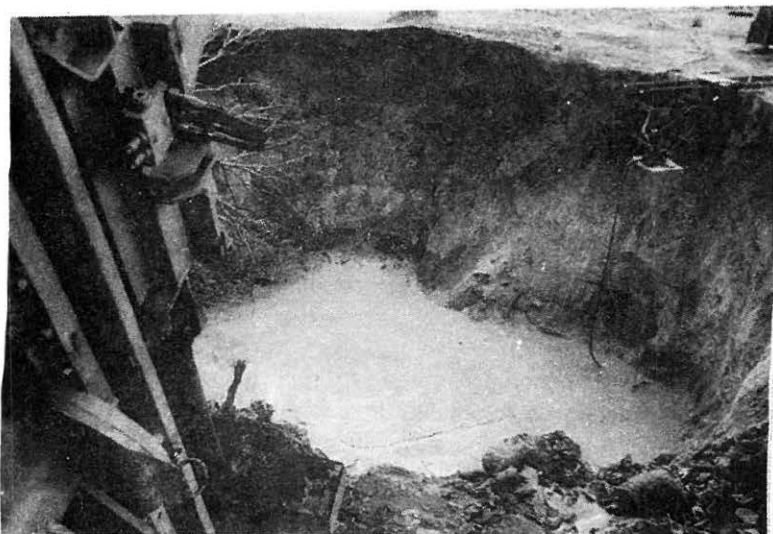
**FIGURE 5b** Details of Cavity at Ch. 151

- D. At Ch 151, the material overlying the crown of the tunnel, was almost entirely made up of completely and highly weathered rock. When the ground got saturated with water, with water table just 4 m below ground, these formations yielded, resulting into puncturing of the crown portion of tunnel and causing a mud flow carrying with it approximately 3500 cum of debris. (Fig. 5). The maximum ground subsidence at this location was approximately 9-12 m.

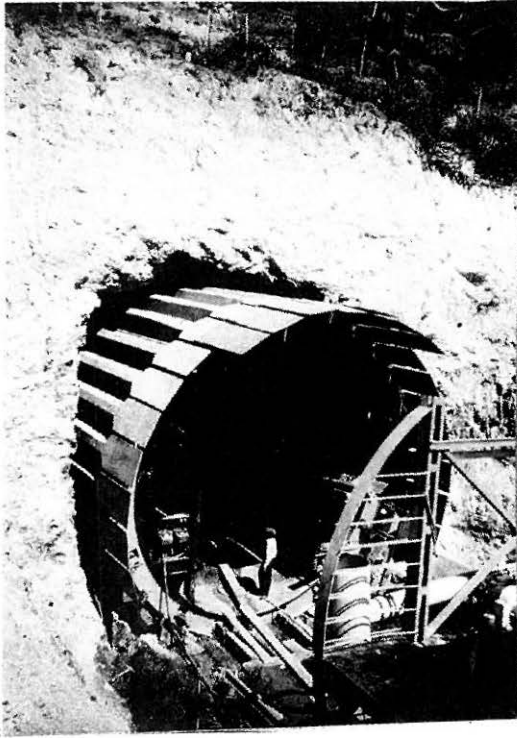
FIGURE 31 View of Blade Shield Unit at the entrance of Honavar Tunnel

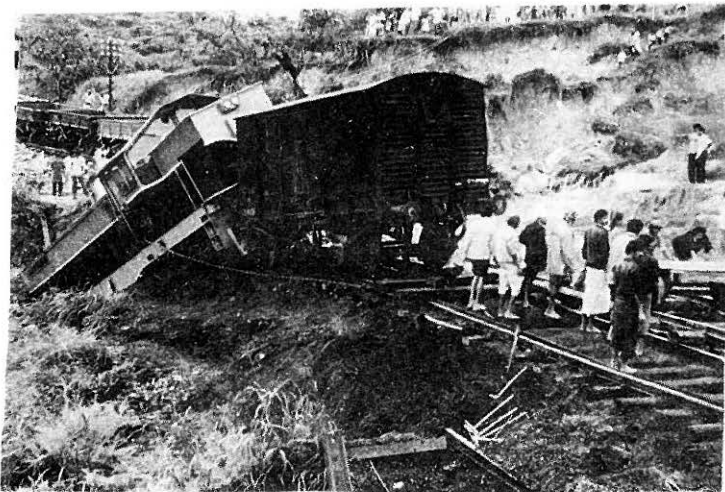
**FIGURE 69** Derailment of Goods Train at Watawala on 3rd June 1992 due to Earth-Slide

On 3rd June, 1992, following a heavy rainfall, the earthslide was once again triggered. This time the engine of a passing goods train was derailed (Fig. 69) on account of failure of track due to slide. Following this slide, detailed investigations were undertaken to study the mechanism of earthslide.
