Short Communication

Analysis of Collapse of a Building

N.V.R.L.N. Rao

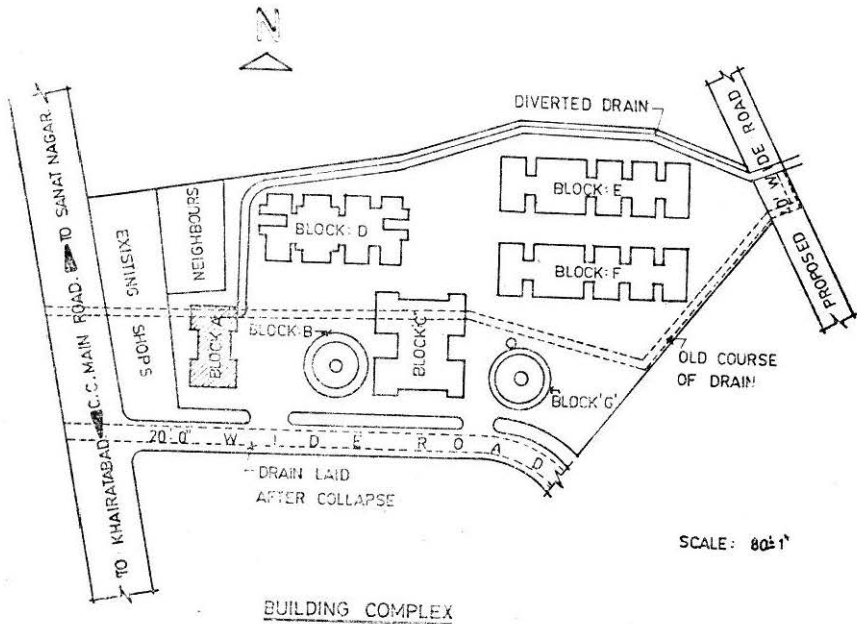
FIGURE 1 Site Plan

The collapsed building A (shown latched in Figure 1) is one of the seven buildings located in the area measuring about 8000 square meters. The area was relatively low lying with a storm water drain passing through it and had been under wet cultivation for sometime. The drain was passing under the collapsed building which could not be diverted because of property line being very close to the collapsed building. The drain has been diverted for the rest of the buildings as shown in Figure 1. The sides of the portion of the drain under the collapsed building were of coarse rubble

masonry pointed with cement mortar and covered with R.C.C. slab before the construction of building (after the collapse, municipality built a large capacity closed drain for storm water passing below the southern side road).

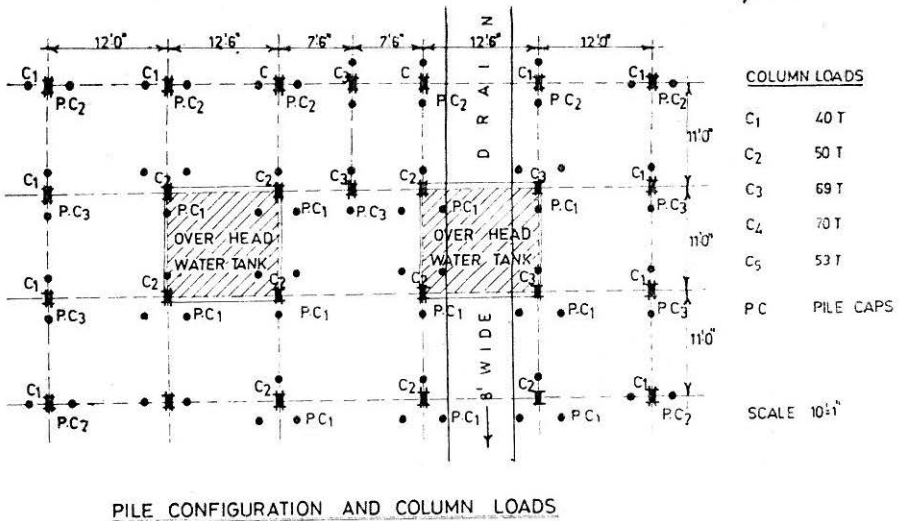
FIGURE 2 Piles, Pile Caps and Pile Loads

Pile foundations consisted of 15" (38.1 cm) diameter stem double under-reamed at 6' (1.8 m) and 10' (3.0 m) depths having bulk diameter of 3'-1" (94 cm) driven to a depth of 4 m. Two piles have been used for under 50 t load columns and three piles for columns carrying higher loads maximum being 70 tonnes. Figure 2 shows pile locations and column loads. Figure 3 shows pile and pile cap details. Pile spacing is 5'-6" c/c (1.6775 m c/c). Pile reinforcement consisted of 6 Nos. 12 mm ϕ longitudinal bars and 6 mm ϕ stirrups 15 cm c/c as against 5 Nos of 12 mm ϕ for longitudinal reinforcement and 6 mm ϕ stirrups 30 cm c/c suggested by IS : 2911 (part III)-1980, giving load carrying capacity of 30 tonnes for 37.5 cm. dia. pile. Design is based on National Building Code and visual assessment of geotechnical properties. RCC components have been designed as per IS : 456-1964. M 15 was used for piles, beams, floors and M20 for columns. Pile caps were connected by beams to transfer the load of the ground floor walls to pile foundations. Steel shuttering was used for RCC work. Mixers and vibrators were used for mixing and compacting the concrete to achieve

quality. The building was completed in about two years (October 79 to Oct. 81). Pile load tests were not done which is an obligatory in all important pile foundations.

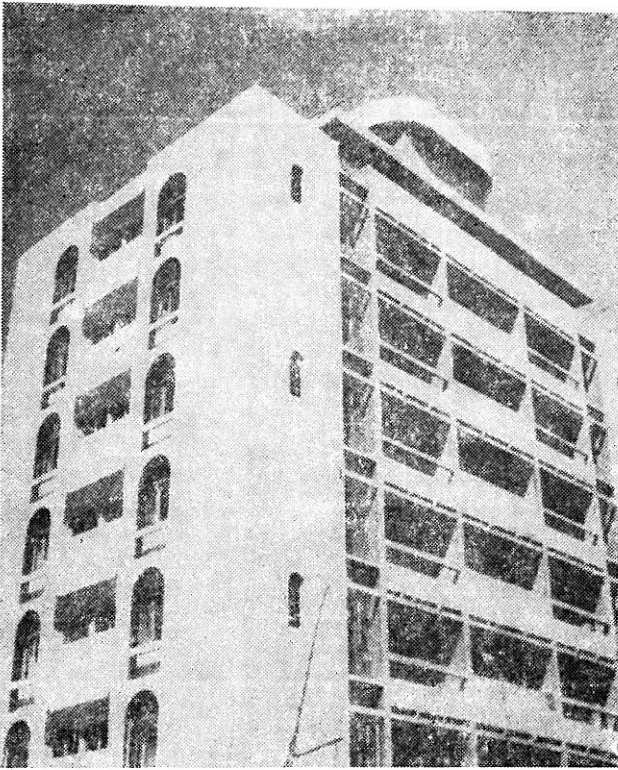
FIGURE 4 Building before Collapse

Figure 4, is the view of the building before collapse. Figure 5 and 6 are the views of collapsed building from eastern side and north-east corner respectively. Figure 7 shows building after pulled down by demolition squad and the neighbouring structure on which it leaned. Figure 8 depicts nature of collapse of first and second floors falling one over the other under impact and punching action of ground floor columns through pile caps into the ground. North-east corner column punched completely into ground whereas south-east corner column is about 2 m above the ground. Figure 9 depicts punching of column through pile cap and also coarse rubble stone face of the drain adjoining pile cap. Figure 10 shows deformation of drain, tilting of piles along drain on either side towards drain. Figure 11 shows north-west corner column which sank first in the process of collapse vertically though during collapse building leaned towards north-west. Figure 12 shows close view of inclination of column and piles by the side of drain which are not in the same direction. Piles have tilted towards drain whereas column towards north-west. Figure 13 shows cracking of plinth beam adjoining drain where office wall collapsed first as a warning to workers in the building. Figure 14 gives tilt directions of piles, deformation of top soil and drain and also penetration of eastern face of columns. The building as a whole tilted towards north-west during

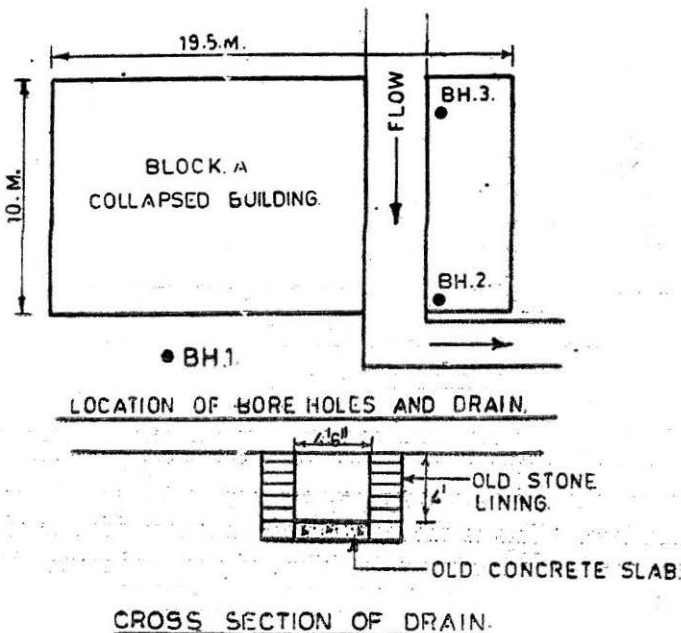
FIGURE 15 Location of Boreholes and Drain.

The location of bore holes driven after the collapse of the building and cross section of drain are given in the Fig. 15. Figure 16 gives log of bore holes and soil properties including S P T values. Bore holes indicate

that the hard strata is met with between 5 to 6 m below ground level. Soil above hard strata is sandy clay having low shear strength. Bore hole No. 2 indicates existance of sand layer between depths 2.7 and 3.4 mm below the ground level. This is the region where initiation of failure of building took place one day earlier by way of falling of plaster of ground floor partition walls.

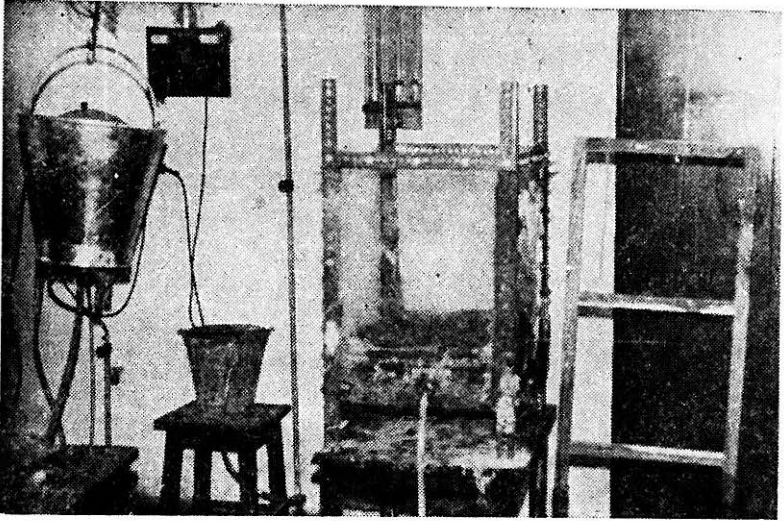
FIGURE 17 Test Arrangement for Study of Liquifaction.

Figure 17 shows experimental set up to investigate the possibility of

occurrence of liquifaction due to saturation. Figure 18 indicates disturbance of soil under hydraulic pressure causing liquifaction.

Quantitative data could not be presented in this article but qualitatively from the photographs of foundation site and laboratory studies on the sample collected from the site of the building, it is concluded that initiation of failure of the building is due to liquifaction of upper sandy clay strata due to choking of drain whose size is obviously insufficient to discharge unprecedented rains two days before collapse.
