A Review of Twenty Years of Geotechnical Studies at Na'ur Landslide No. 4 in Jordan

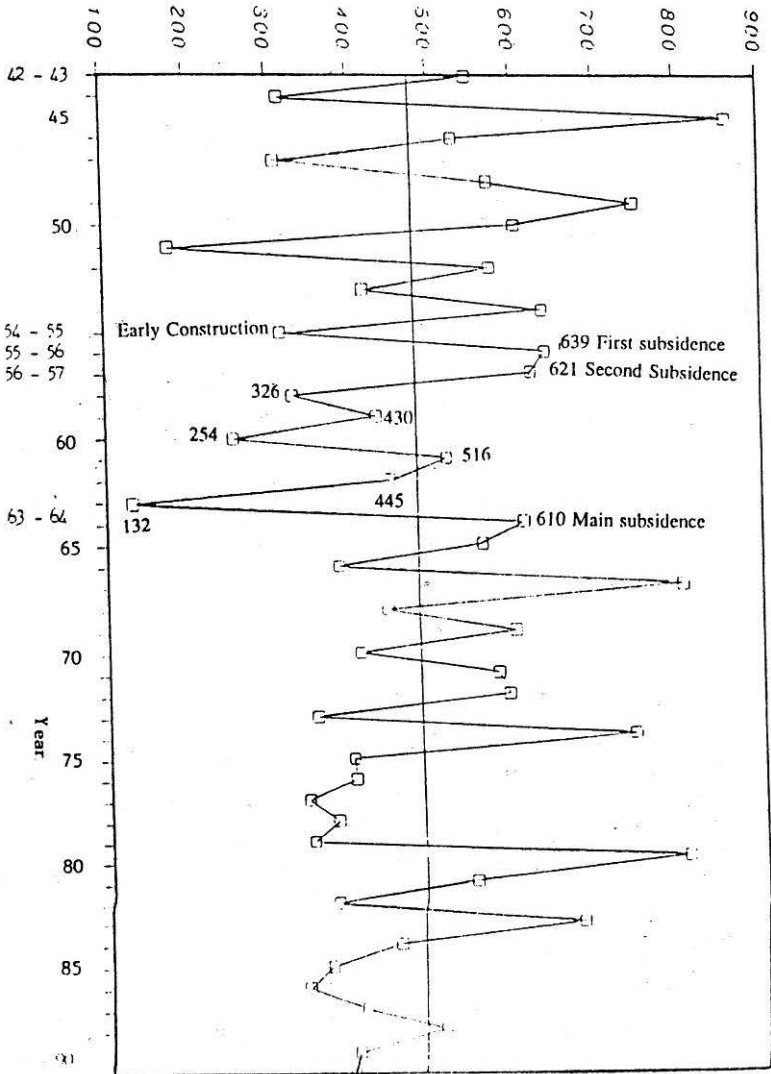
FIGURE 3 Rainfall Records at Na'ur Station

The average annual precipitation (measured over a 50 years period) in the study area is 482 mm. This rainfall is usually concentrated in the period between November and May. The annual precipitation during the period between 1942 and 1990 is illustrated in Fig. 3. There are no perennial flows in the wadis at the landslide area. The discharge is limited to the seasonal rainfall.

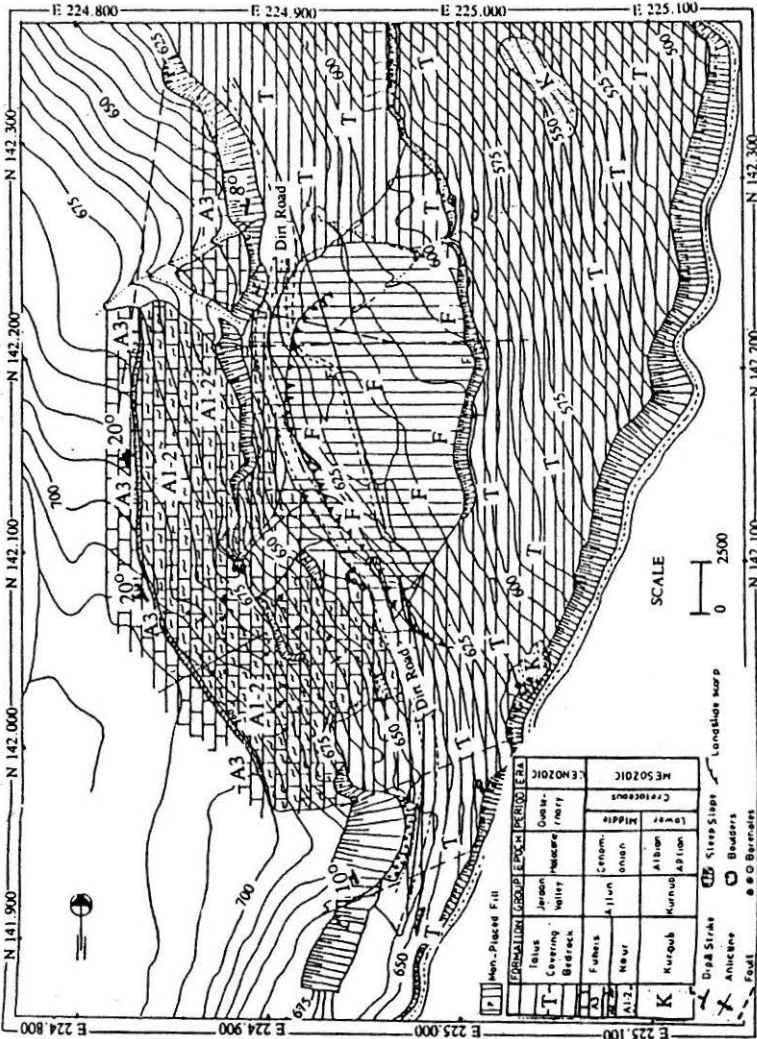
FIGURE 5 Geological Map of Na'ur Landslide No.4

In the vicinity of Na'ur landslide No. 4, the outcropping rocks consists of alternating limestone, dolomitic limestone and marls of the lower Ajlun Group (A1-2, A3) of Middle and Upper Cretaceous Age. These rocks overlie the Kurnub Sandstone Group (K) of Lower Cretaceous Age. Where rocks are not exposed, a surface cover of weathering products is present (Fig. 5). The geological sequence of the area of Na'ur landslide No. 4 is shown on Table 1.

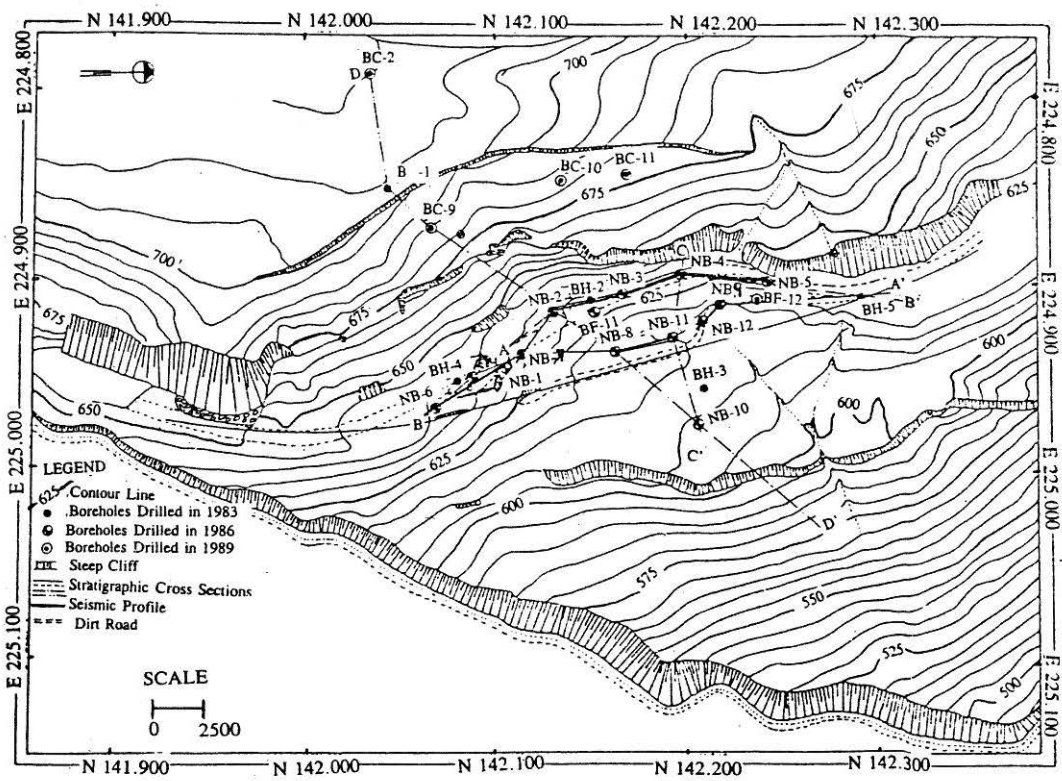
FIGURE 6 Detailed Location Map of Borholes Drilled at Site of Na'ur Landslide No.4

The area of landslide No. 4 has local variation in soil and rock quality and characteristics. From the different boring made in the area of the landslide (Fig. 6), the subsurface materials encountered can be divided into three generalized strata. These strata vary in thickness from one borehole to

Geotechnical Engineering and Materials Testing Co. (G.E.M.T.) has studied this landslide in the years 1982, 1987 and 1989. Several boreholes were drilled during these periods. The locations of these holes are shown in Fig. 6.

In 1982, five boreholes were drilled (indicated in Fig. 4 as B.H. 1 through B.H. 5). The maximum depth reached in these holes is 55 m.

In 1987, twelve boreholes were drilled in the area (indicated in Fig. 4 as NB 1 to NB. 12). The deepest borehole was 64.7 m deep, where the Kurnub sandstone was encountered.
