## **Foundations of the Indian Museum Building, Calcutta**

**Devendra Sharma\* and D. Roy†**

### **Introduction**

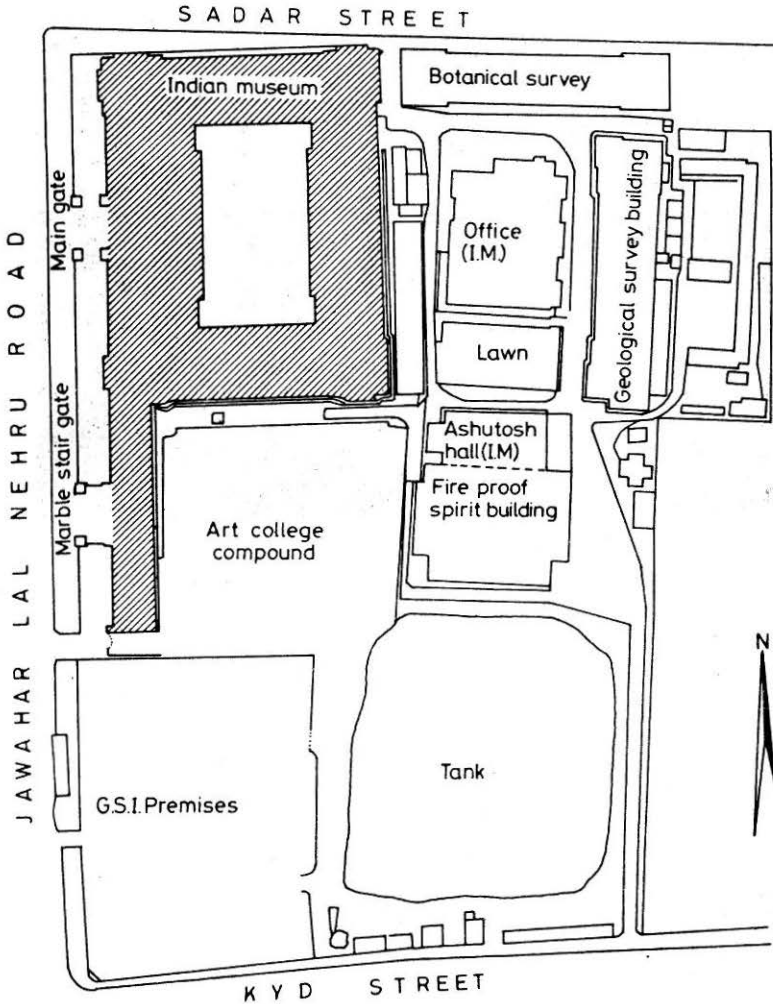
FIGURE 2 : Key Plan

Several cracks could be observed in the walls and the arches may be due to both the deterioration of material and differential settlement. It could be noticed visually in the courtyard that the southeast and southwest corners have sunk down. The front block facing Chowringhee has settled more over the years as compared to the rest of the building as evidenced by vertical cracks wider at top in the walls of north and south blocks (Fig. 7). Loss of adhesion in the mortar, rusting of RSJs and seepage of water from roofs and fittings for sanitary and water supply and consequent adverse effects were also visible at certain locations. On account of repairs from time to time it was not possible to identify all the cracks hidden under plastering

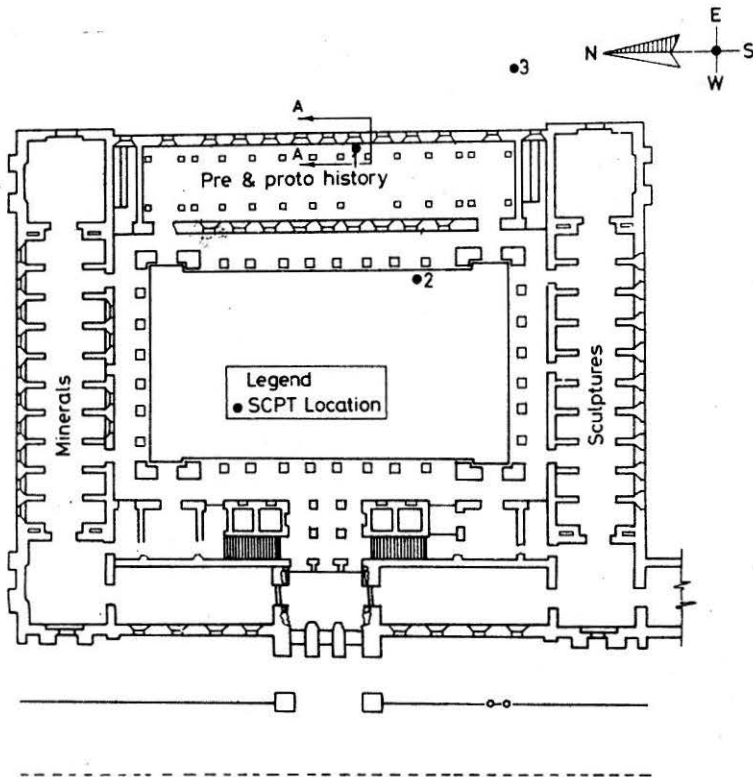
FIGURE 4 : Ground Floor Plan of Main Quadrangle

The building consists of load bearing walls and columns (Fig. 4) supporting arches and girders over the openings and for supporting the roof (Figs. 5 and 6). The outer wall is 1.4 m thick. The brick columns of different sizes have been provided. The column size in the display gallery on the eastern side is 76 cm  $\times$  76 cm on plinth of 92 cm  $\times$  92 cm. The bricks used are of nominal size 10 in  $\times$  5 in  $\times$  3 in. The brickwork is in lime mortar. The intermediate floor and roof mainly consist of thick RSJ as the main load bearing girders supporting cross T sections laid over with tiles and lime concrete.

The museum building complex has very limited open space. Incidentally the ground floor gallery on the eastern side had been vacated for repairs and this provided an opportunity for foundation investigations by digging a pit in between the outer wall and the row of the columns (Fig. 4). A static cone penetration test was also carried out adjacent to the pit. Two more static cone penetration tests were carried out in the open courtyard and on south-east behind the building (Fig. 4). Information on soil strata along with standard penetration test carried out by another agency was available from site near the Indian Museum Building.
